City of Lake City Downtown Preservation Design Manual

Prepared for
The Lake City Heritage Preservation Commission

Thomas R. Zahn & Associates
Fall 1989

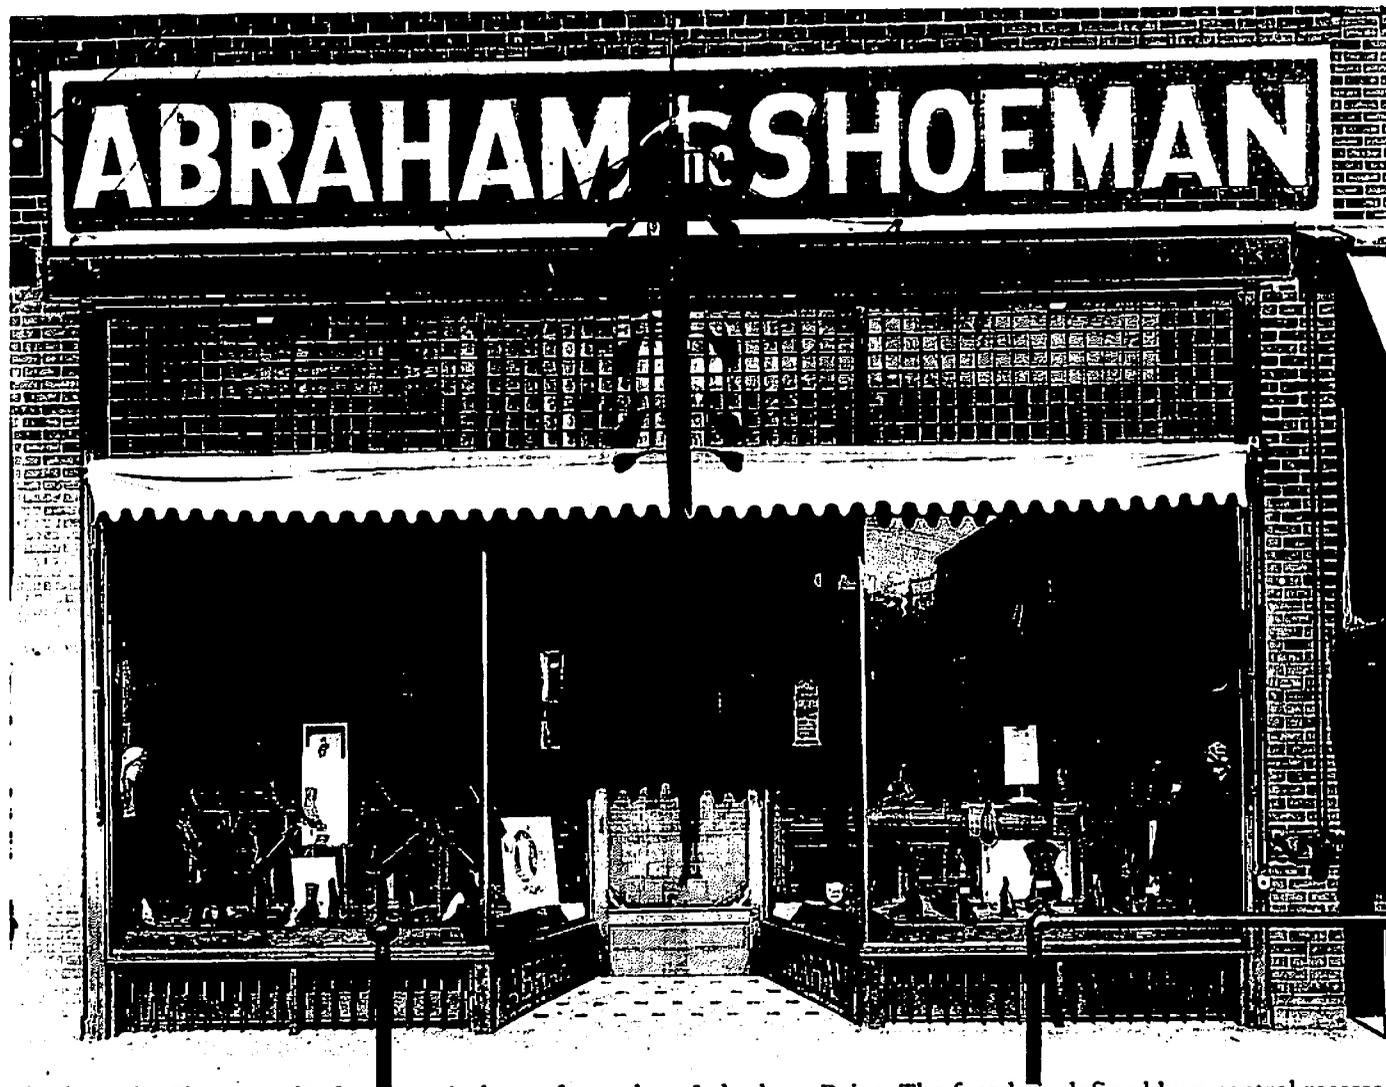
Abraham the Shoeman displays a typical storefront along Lakeshore Drive. The facade is defined by a central recessed door, large plate glass display windows with bulkheads below and prism-glass transoms above, a retractable canvas awning and signage above.

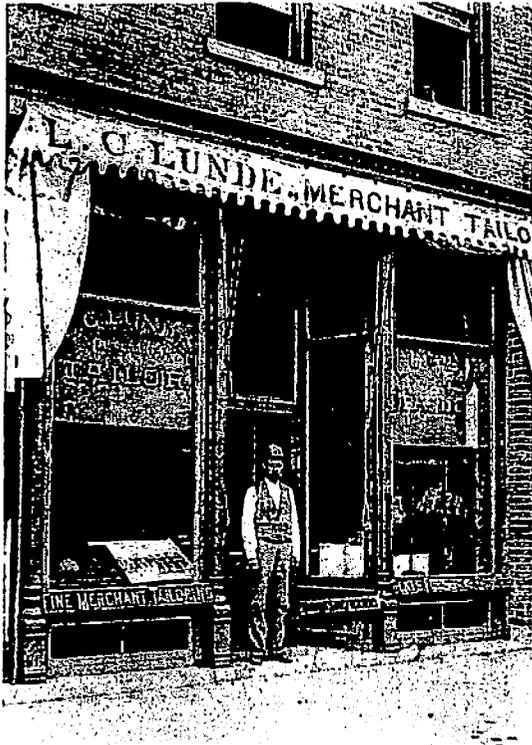
The facade of the L.C. Lunde Merchant Tailor building displays a typical turn-of-the-century storefront in Lake City. Note that the signage is limited to flat architectural surfaces and to the canvas awning's fringe.

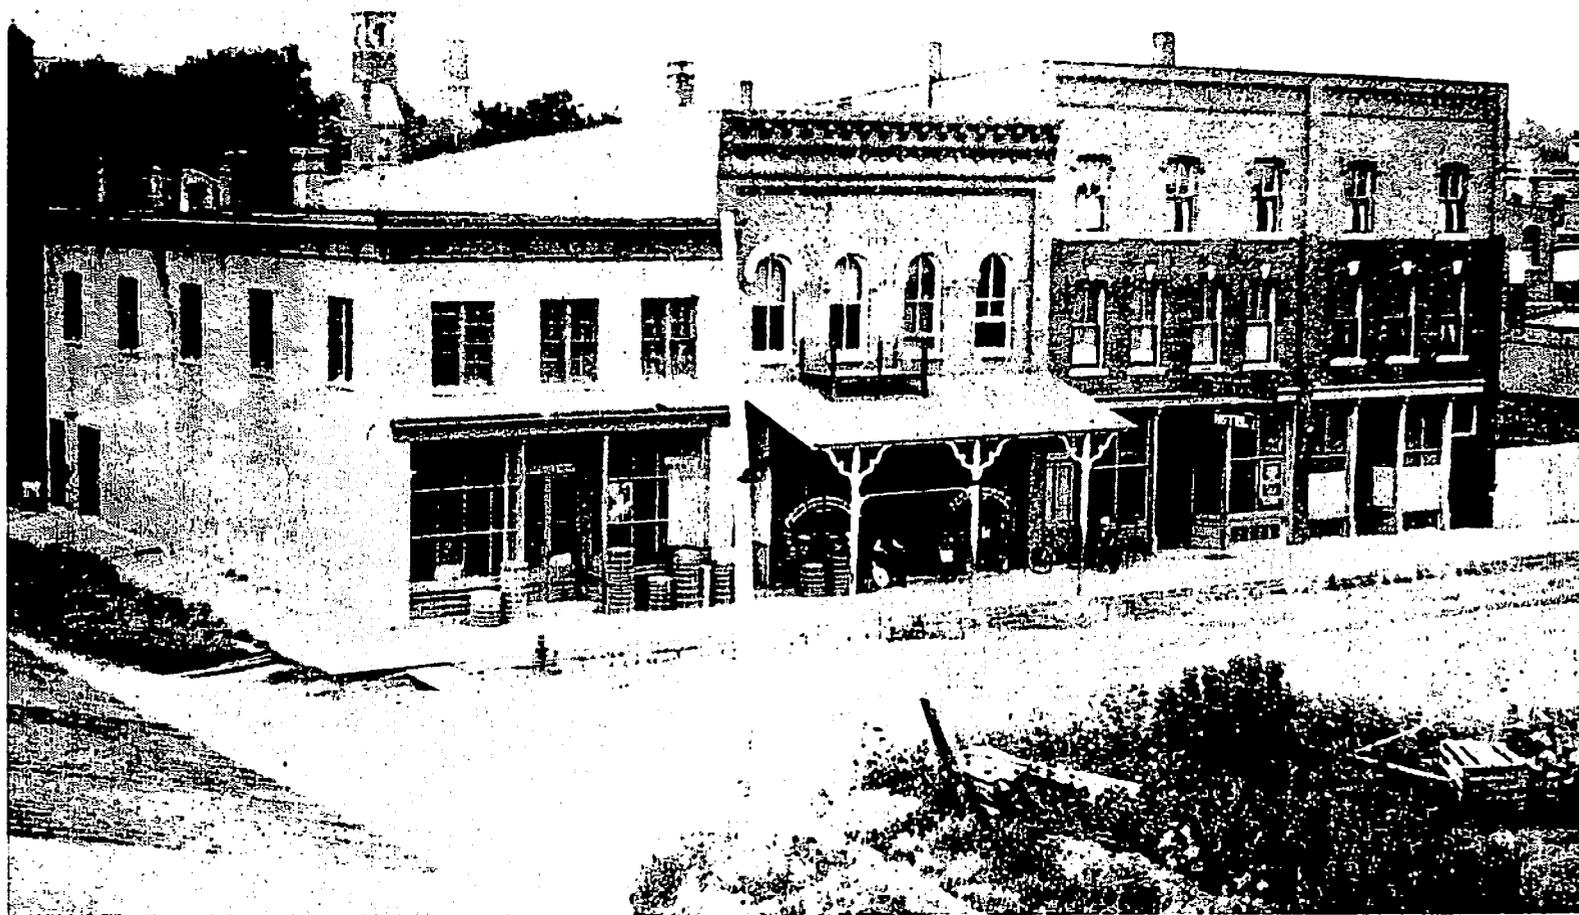
A late nineteenth-century photograph showing from left to right, the John Stouts General Store (Lake Pepin Pearl Button Company) building at 226 South Washington Street, the George Patton General Store (Rueckert Hardware) at 224 South Washington, and the Merchants' Hotel at 220-222 South Washington. Note that the upper story of the hotel appears to be an early expansion.

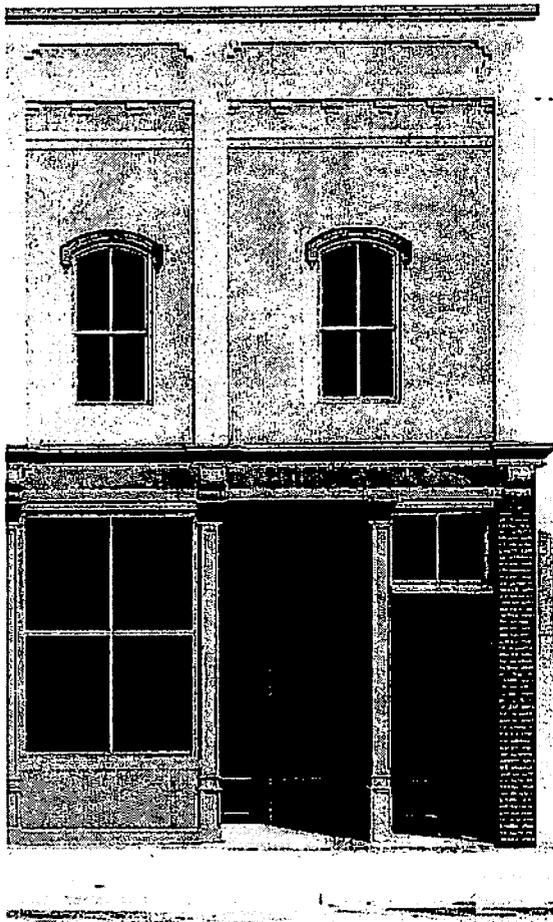
This facade shows a variety of finish materials common to commercial buildings in Lake City. The storefront displays a predominant use of wood and glass framed with a structural brick side wall. The upper story displays stucco over brick with the windows framed and crowned with wood elements.

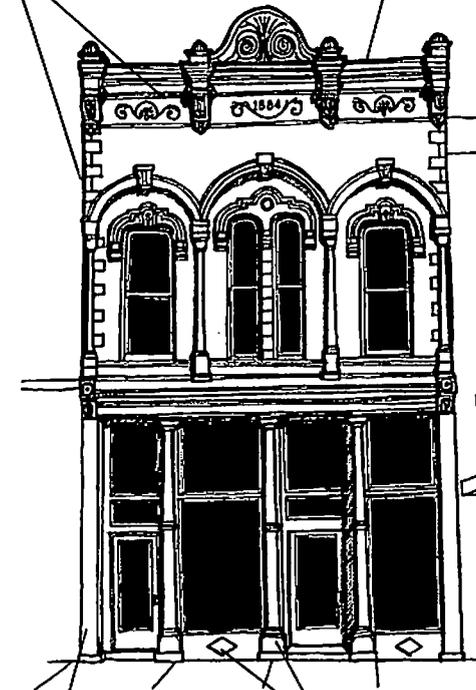
Cornice

Visually crowns the building

Pilasters

Masonry pilasters provide the structural and visual framing for the first floor storefront

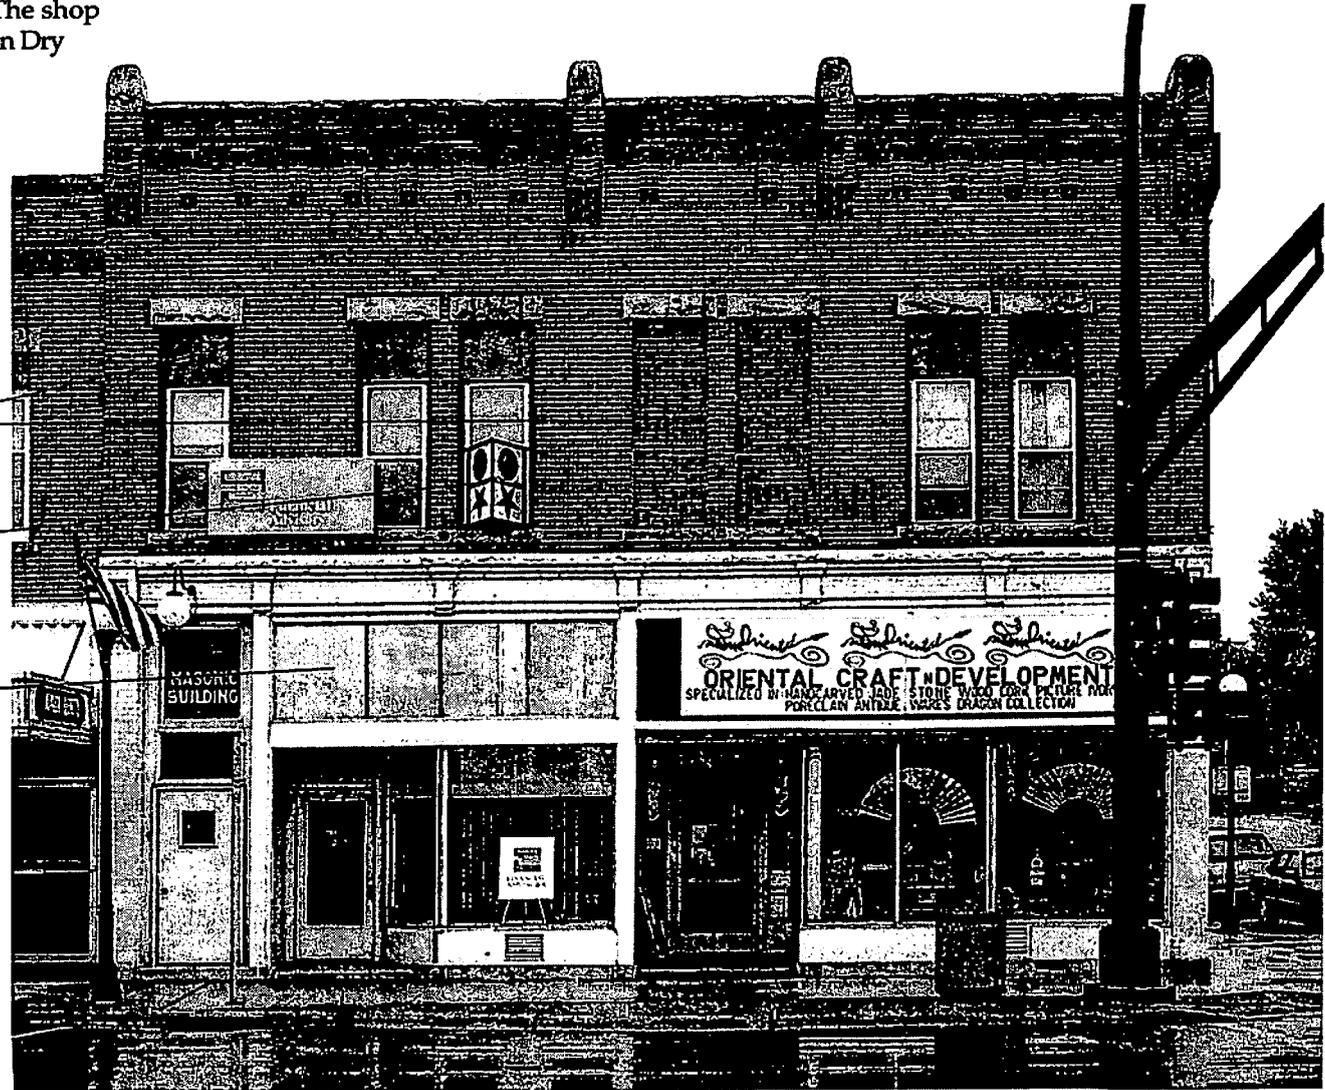
The upper portion of the front facade is still intact and in good condition

The storefront is basically intact

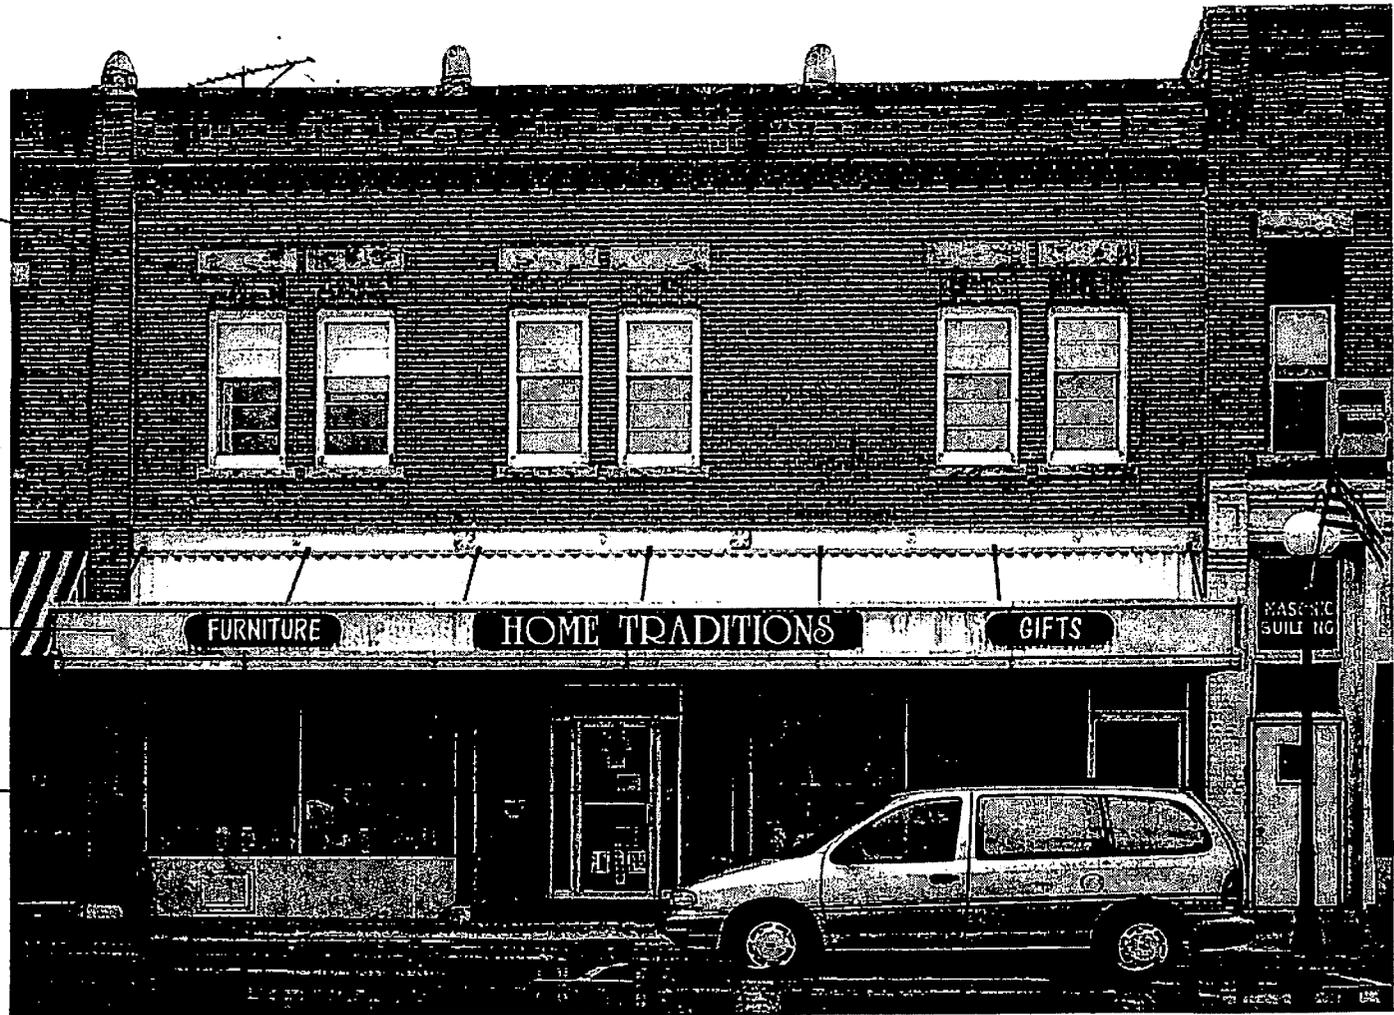
The original wood doors have been replaced with modern extruded aluminum and glass doors, transoms and sidelights

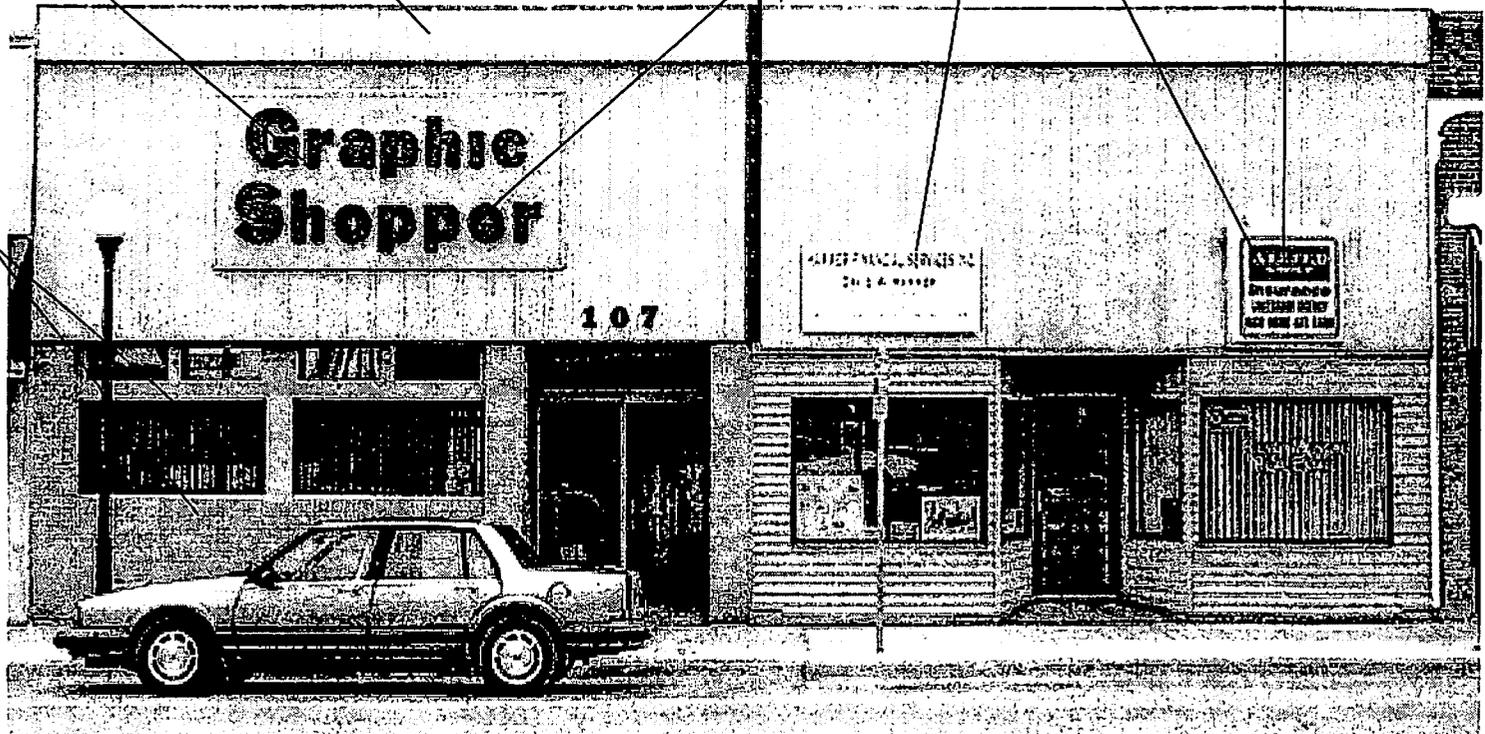
The original storefront with its large display windows and transom has been replaced modern brick infill and higher, less inviting windows

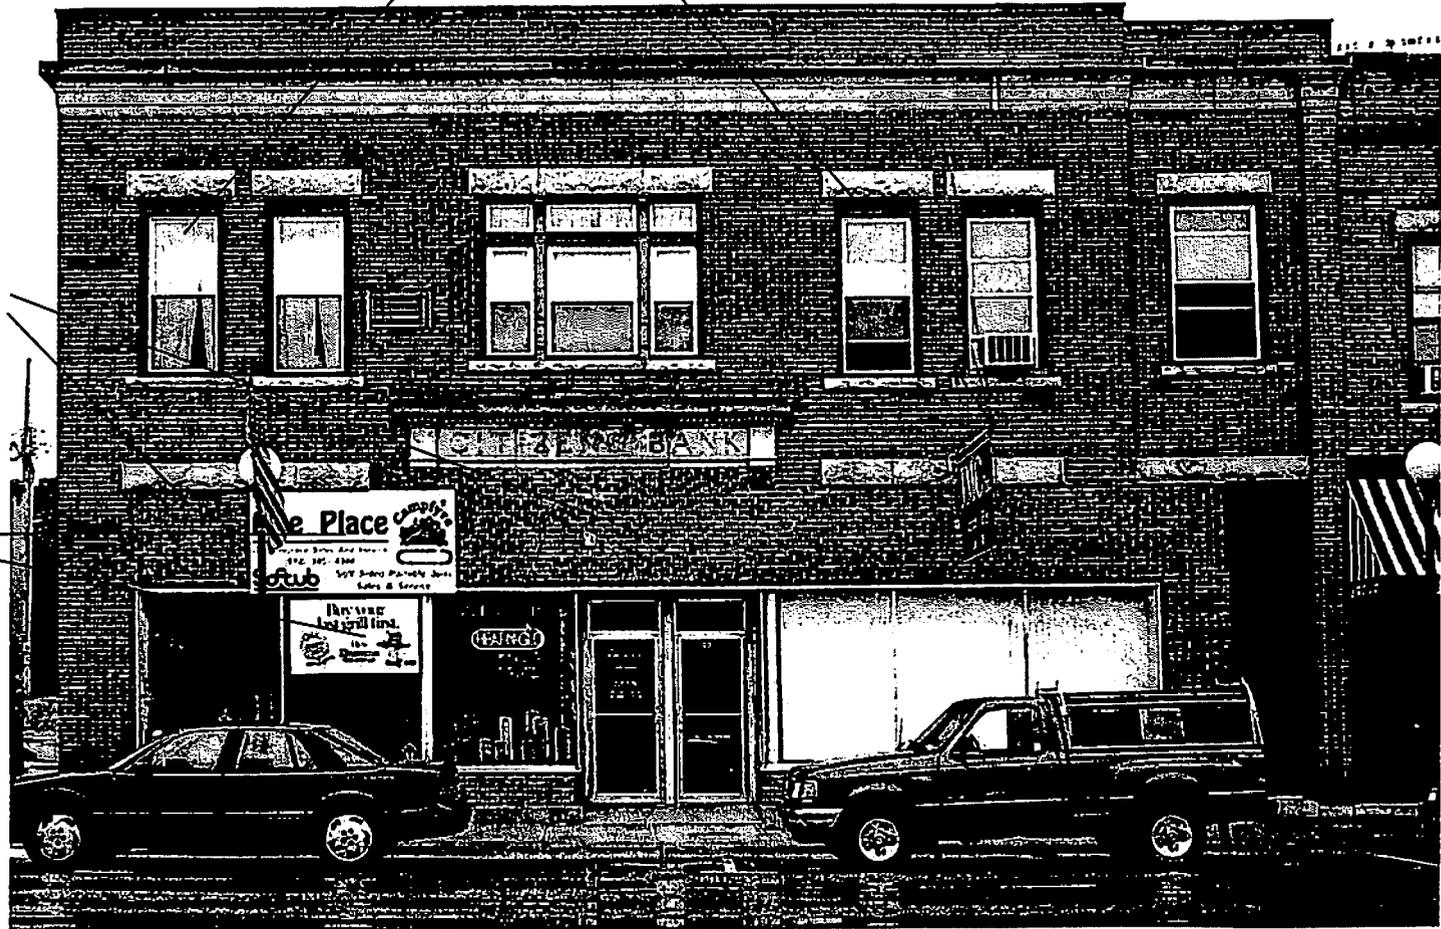
Signage is randomly placed on the facade adding confusion to the storefront

A modern storefront was cut into the front of the building with no regard for the original design

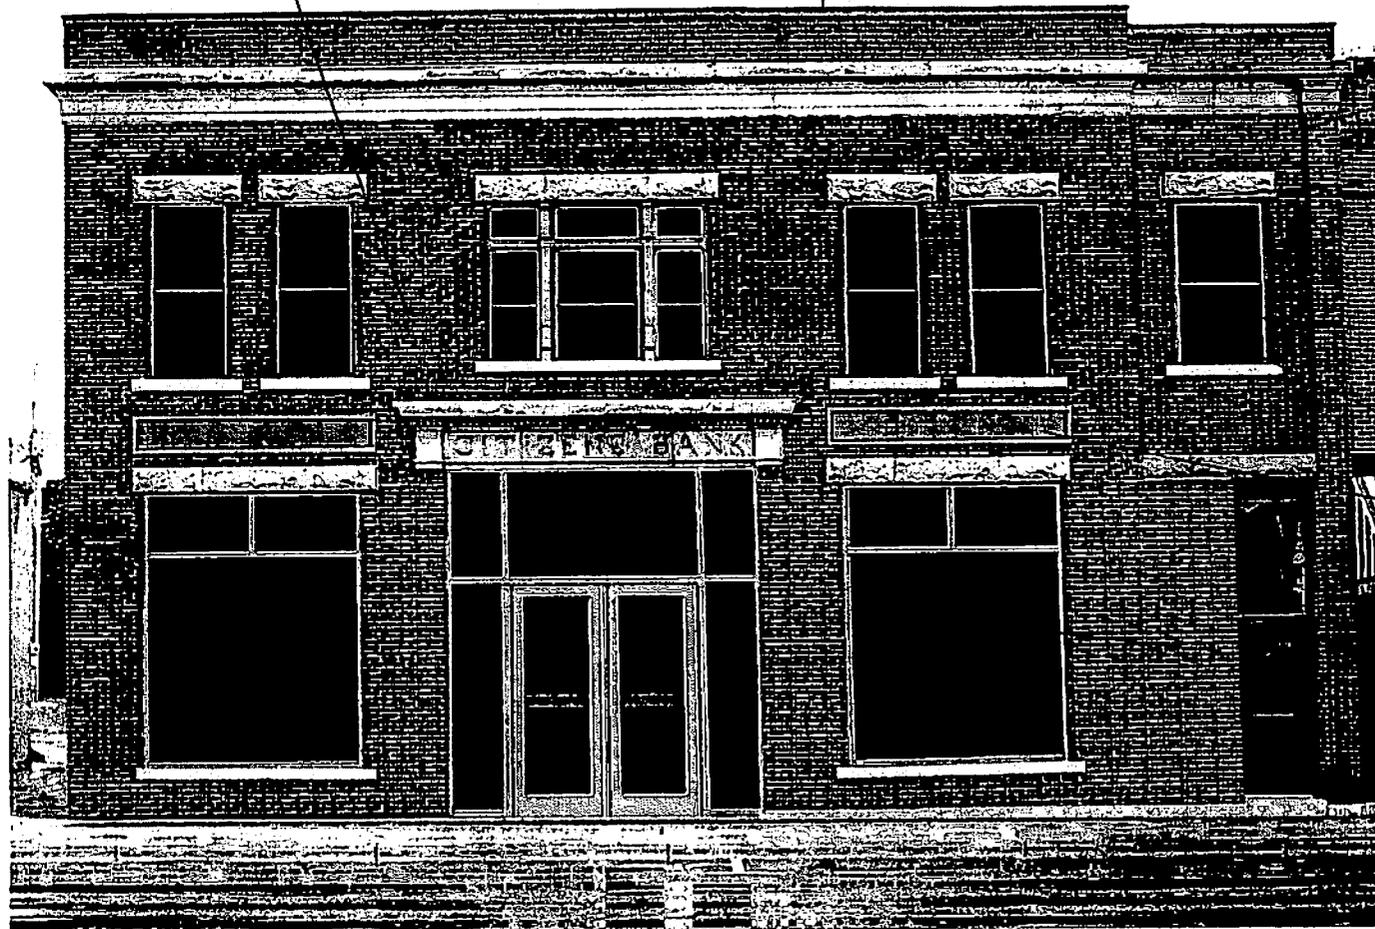
PROPOSED RENOVATION

Remove air-conditioner
and patch hole with matching
brick and mortar

Inspect roofing and flashings

Tuckpoint and repair brick
as necessary

Clean and repair stone on
cornice and above and
below window openings
and doors

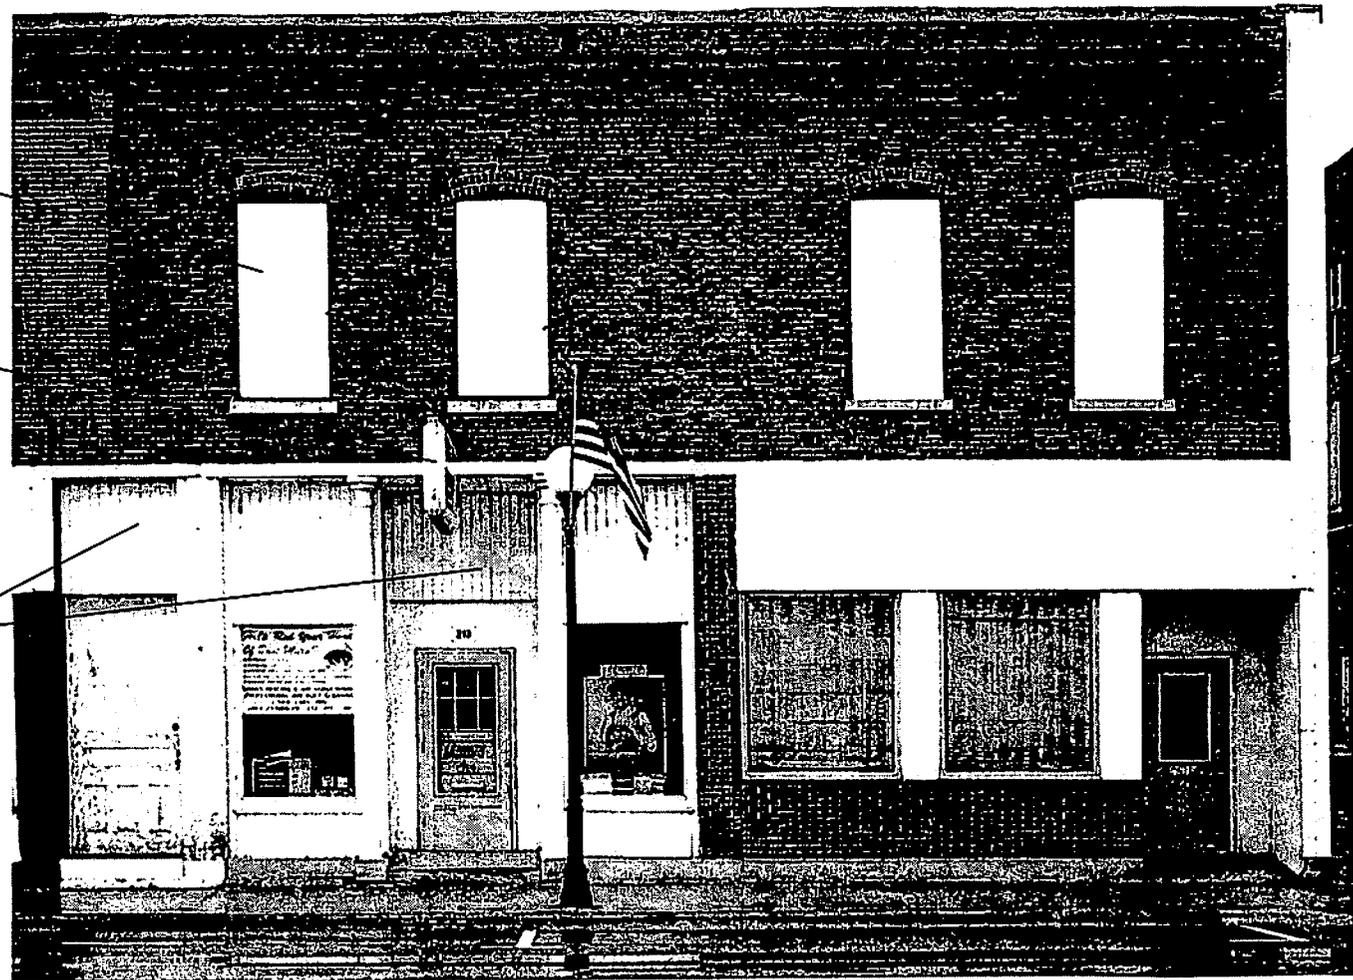
While the left side of the building retains many of its architectural elements, the transoms have been infilled with vertical wood siding and the display windows and doorway down-sized and modernized

The storefront on the right side has been severely modified through time

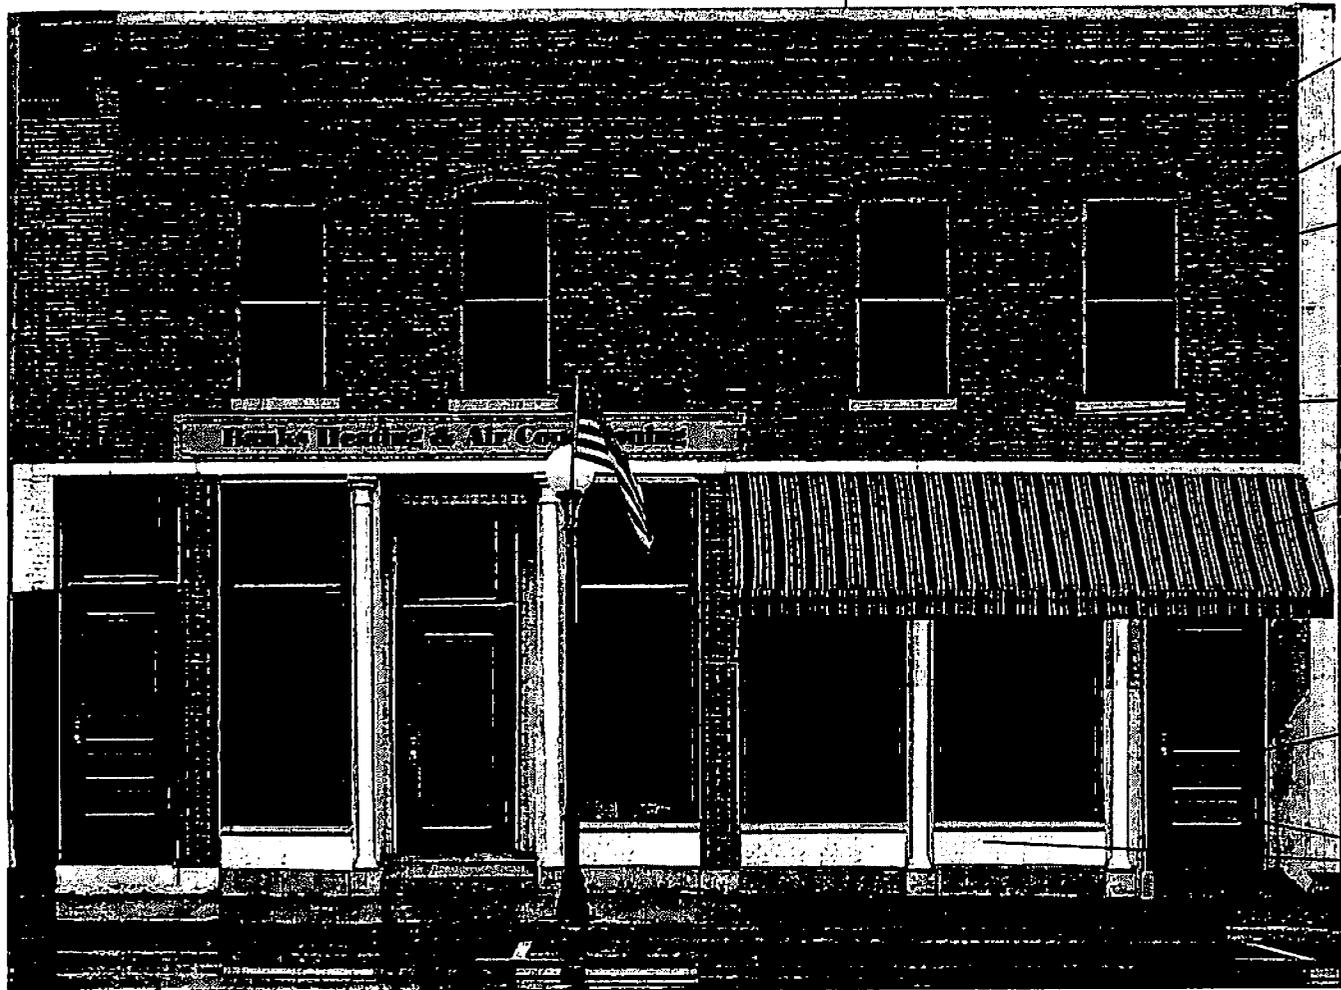
PROPOSED RENOVATION

Inspect roofing and flashings

Tuckpoint and repair brick as necessary

Repair, clean and repaint window trim

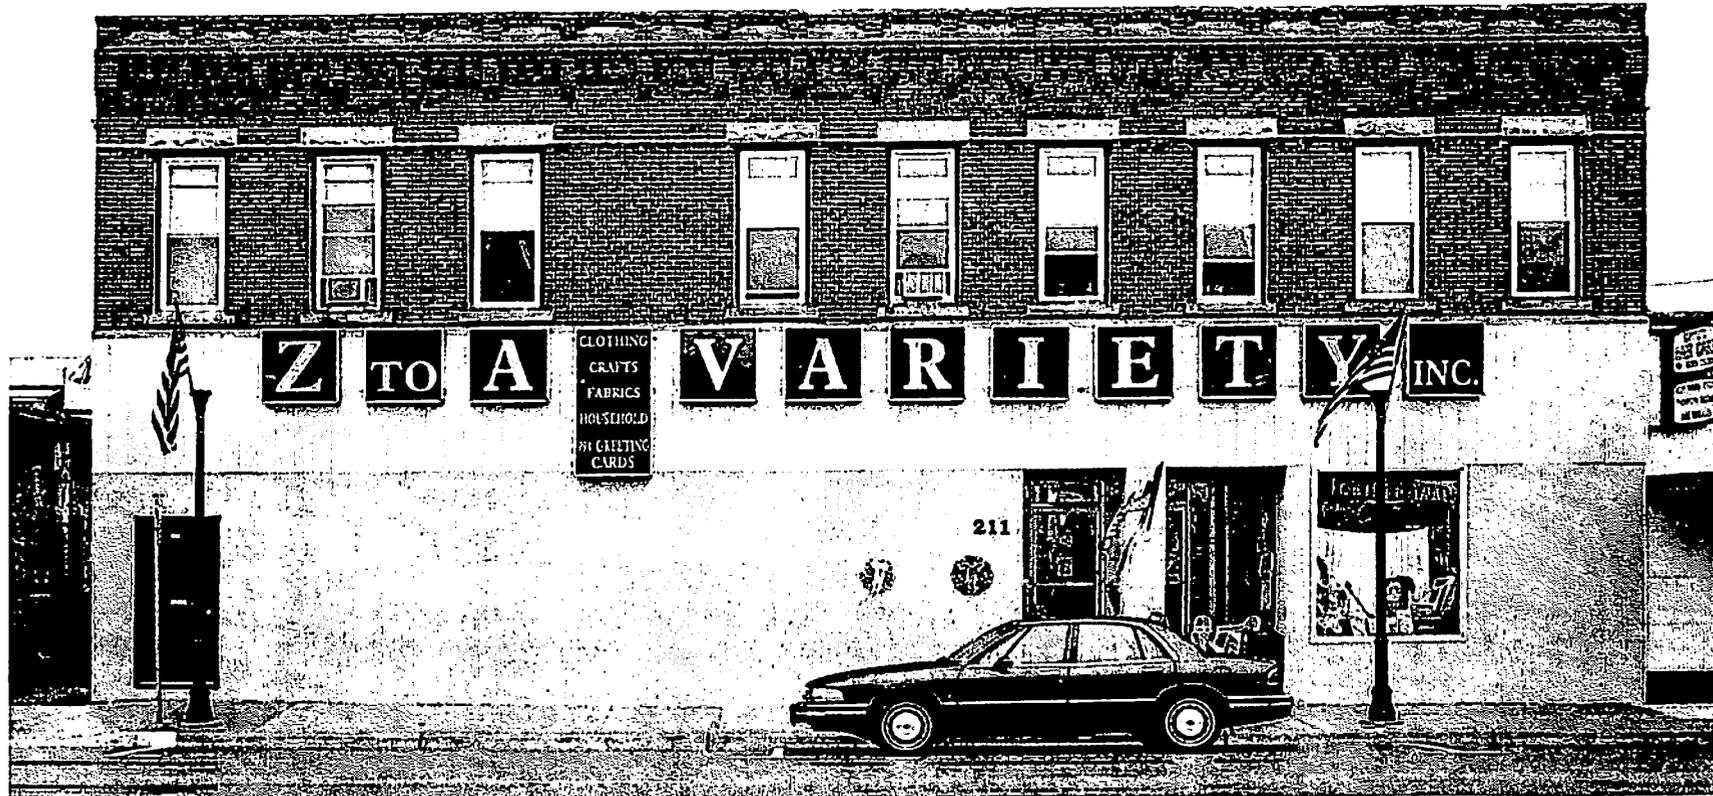
The upper story remains virtually intact, with the exception of the extruded aluminum storm window addition. The storefront has totally been covered and rearranged with vertical siding, new entries, and backlit oversized plastic signage which is inappropriate and intrusive in an historic downtown.

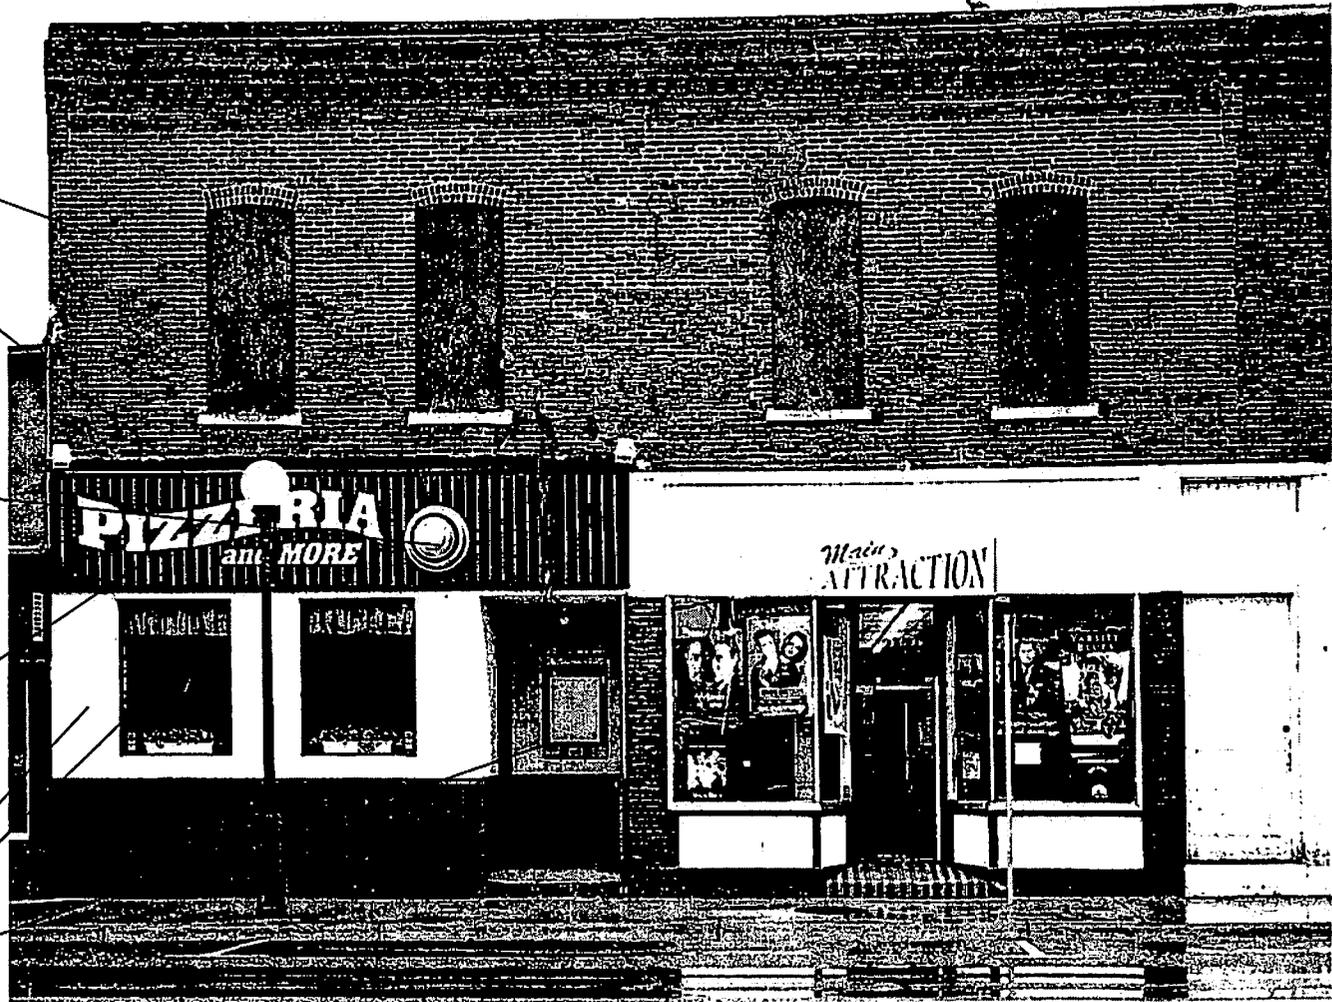
While the right side of the building retains many of its architectural elements, the transoms have been infilled with vertical wood siding

The storefront on the left side has been severely modified through time with modern vertical siding, down-sized display windows and a change in the entry door placement

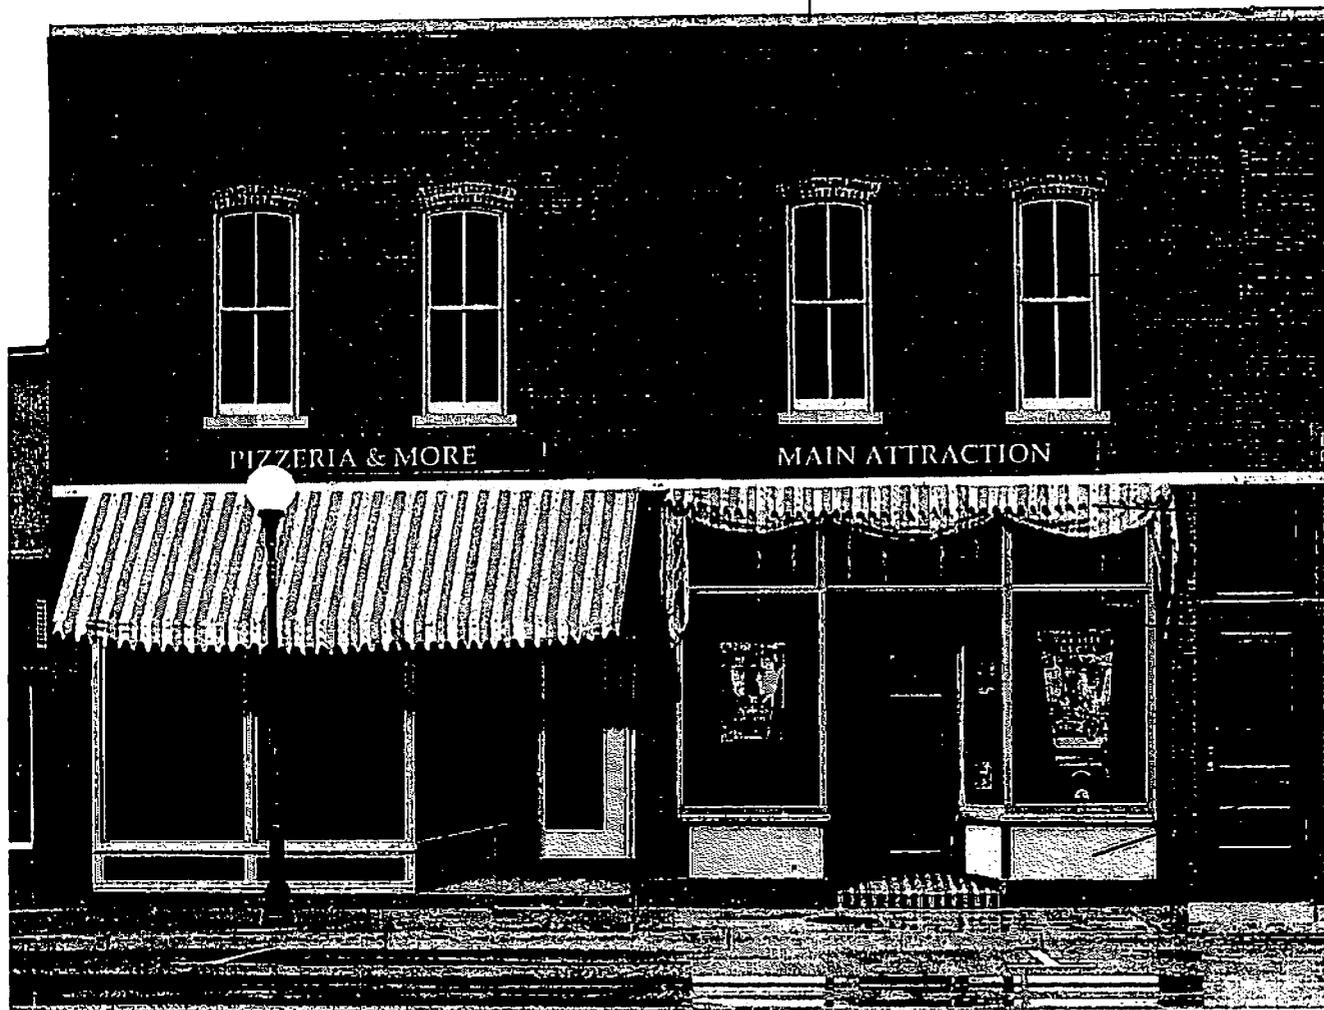
PROPOSED RENOVATION

**Remove ventilation unit
from the front facade**

Inspect roofing and flashings

**Tuckpoint, clean and repair
brick as necessary**

**Repair, clean and repaint
window trim**

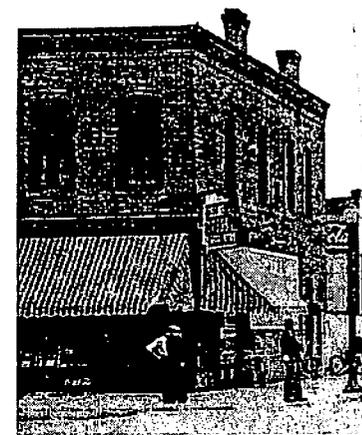
The "modernization" of 100 East Lyon Avenue displays the inappropriate and arbitrary use of shutters, fixed/bowed awnings, and vertical wood-siding infill at the corner entrance

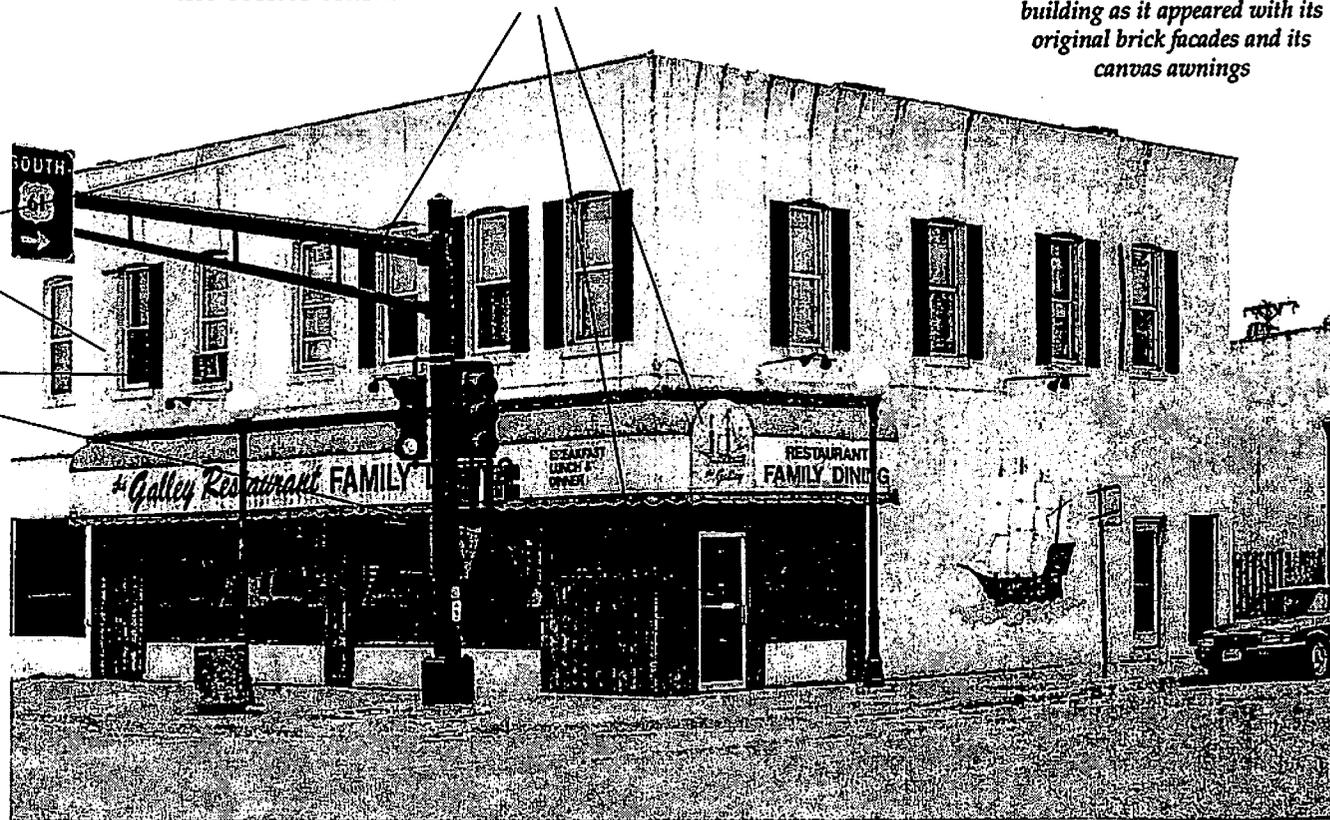
Original brick facade and corbelled cornice is covered in stucco

Original historic windows and doors replaced with modern "extruded" aluminum framed fenestration

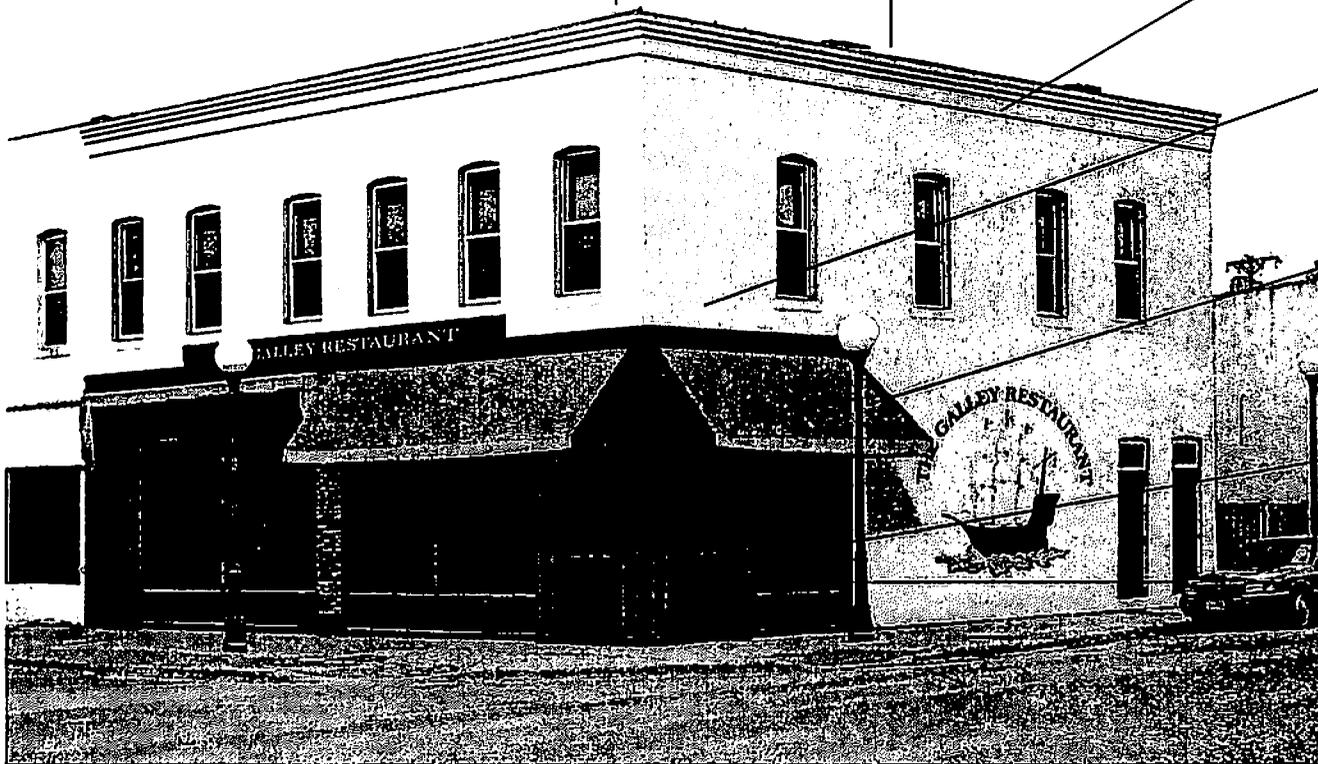
PROPOSED RENOVATION

Work with the MnDOT and local public works to minimize the intrusion of traffic signs and standards within the historic district

Remove all modern "extruded" aluminum framed windows and doors and replace with more historic materials

Replace modern storefront with appropriate materials and original configuration

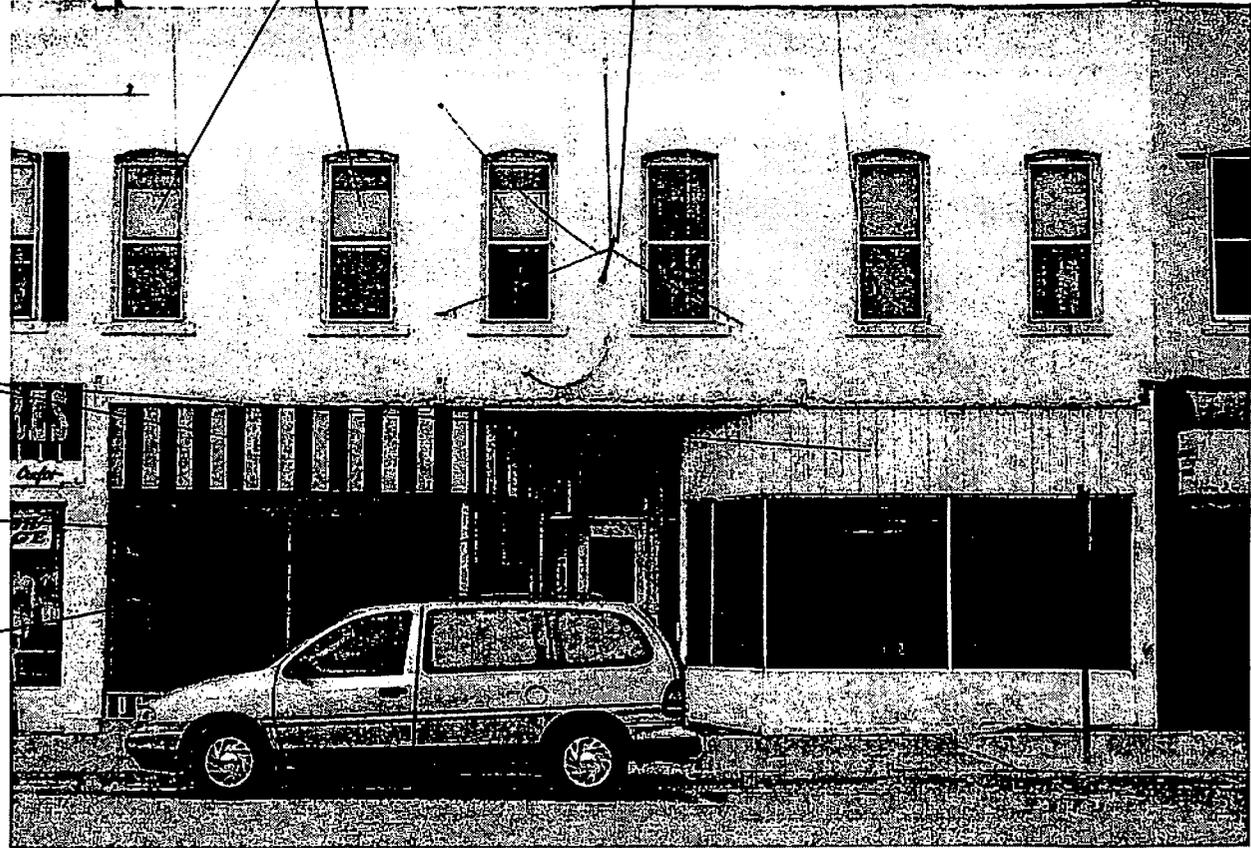
Modern plate glass
windows and entry doors in
extruded aluminum frames

Air-conditioning unit
projecting out of
the front entrance

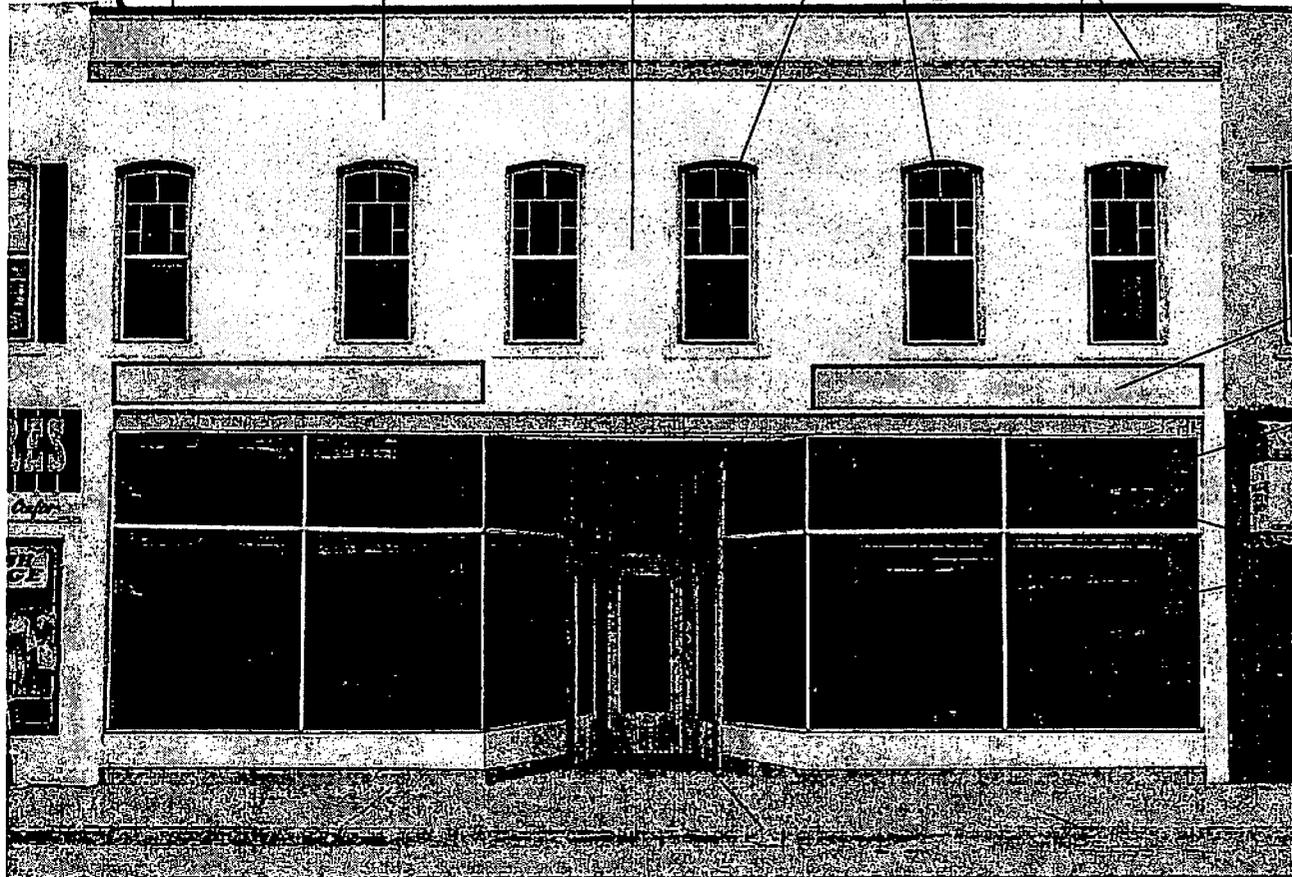
PROPOSED RENOVATION

Repair existing windows or replace with insulated double-hung windows. Consider restoring the upper sash to their original configuration

Remove all projecting hardware from the facade

Introduction of another color and/or molding strips to emphasize crown on building

Place commercial signage on a flush signboard over the transoms

Add canvas awnings as originally designed
