City of Lake City Downtown Preservation Design Manual

Prepared for
The Lake City Heritage Preservation Commission

Thomas R. Zahn & Associates
Fall 1989

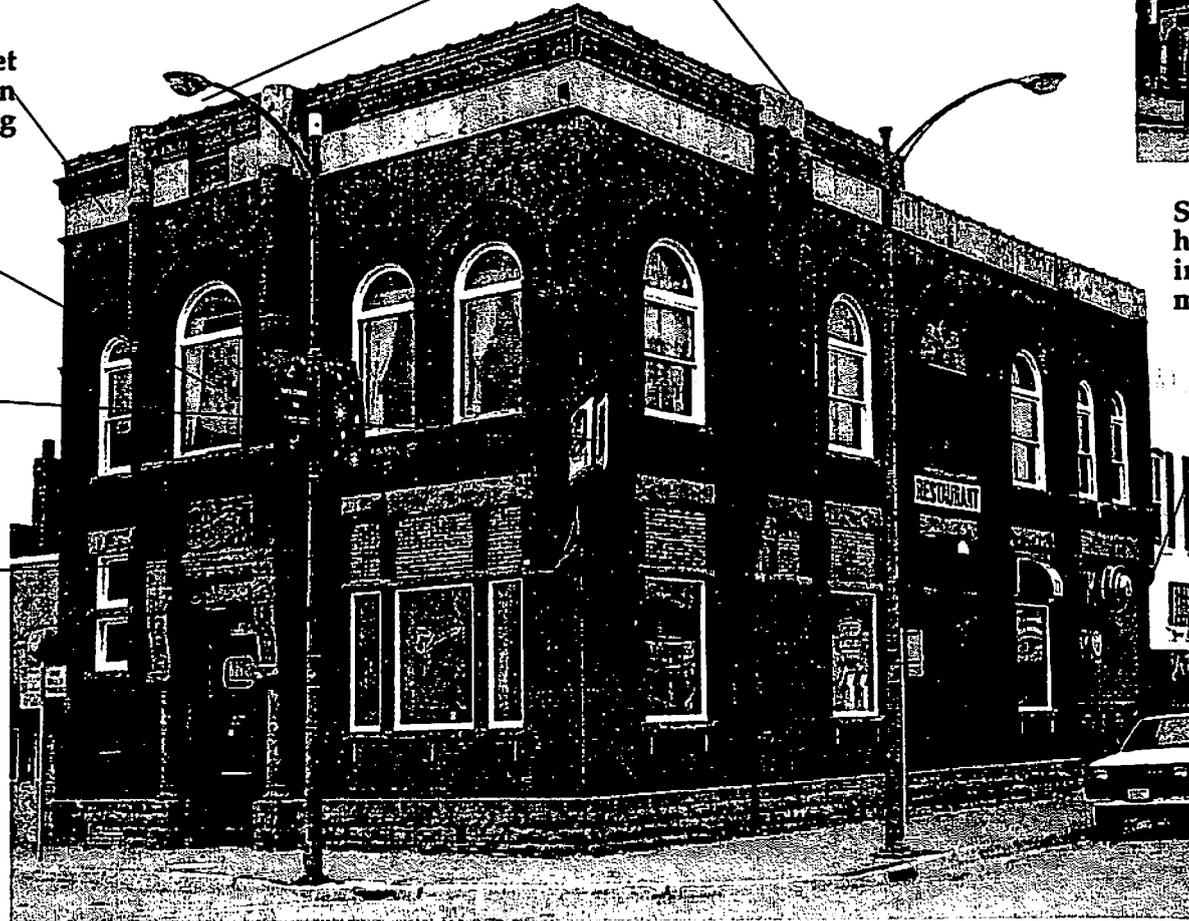
Backlit plastic signs are inappropriate in historic downtowns

The transom windows of the first story have been infilled with modern brick

Side storefront has been infilled with modern brick

A variety of mechanical vents and enclosures dot the side elevation

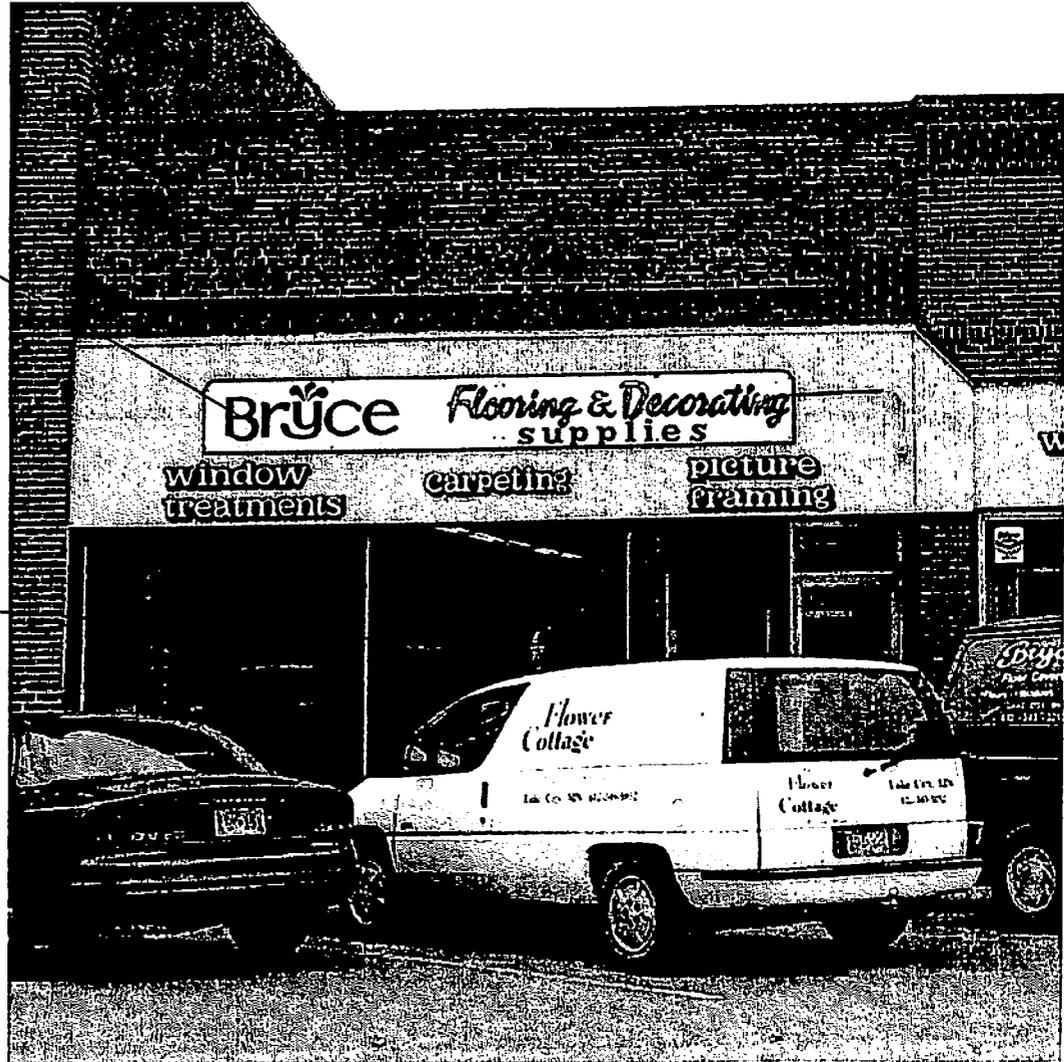
The architecture of this simple brick commercial building is dominated by over-sized signage

The display window/door relationship has been modified over time with the introduction of modern aluminum framed windows and doors

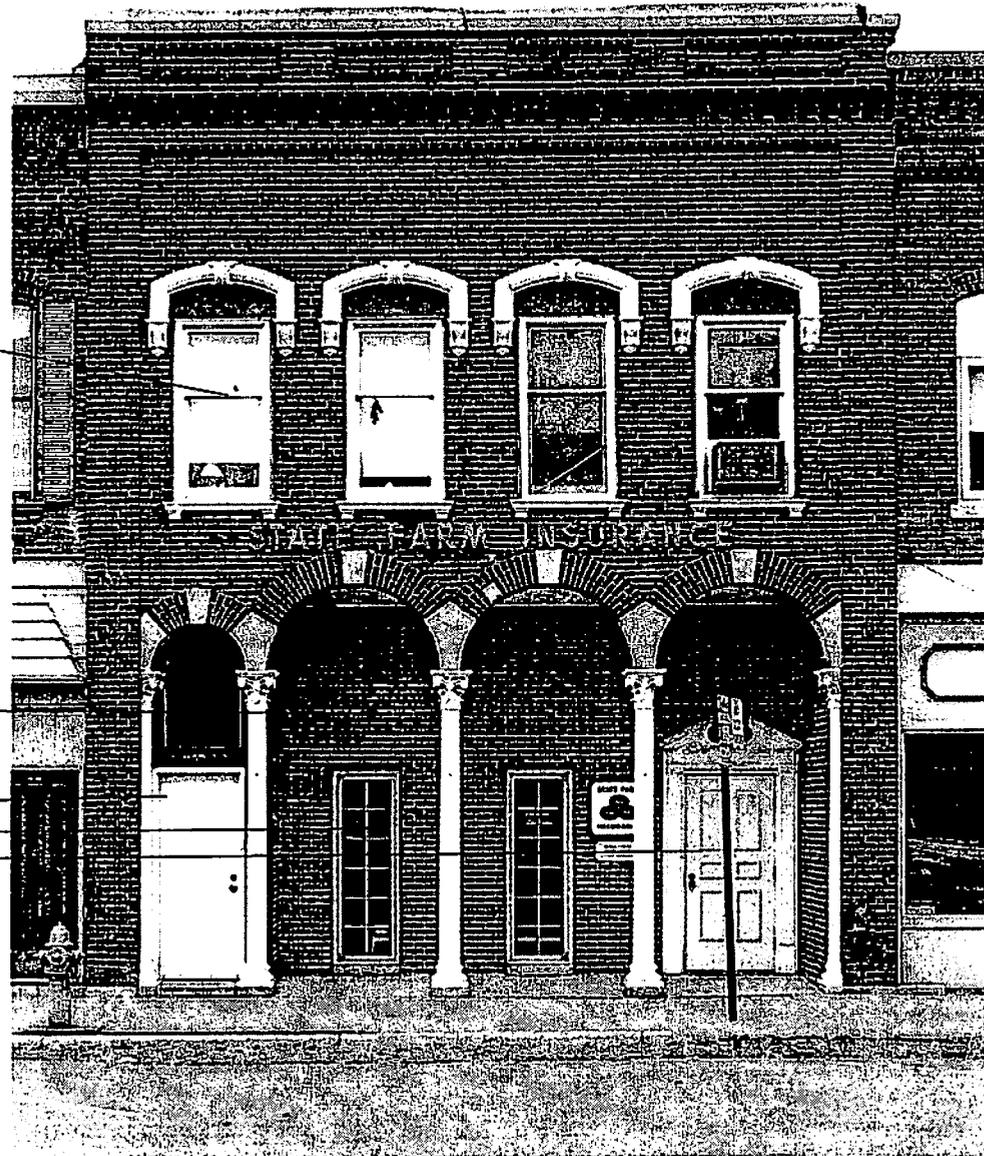
The original tall doors and display windows have been removed and a new recessed wall plain has been constructed

The modern side door, tall and narrow windows and the Georgian style door with broken pediment above are all inappropriate to the original architecture of the building

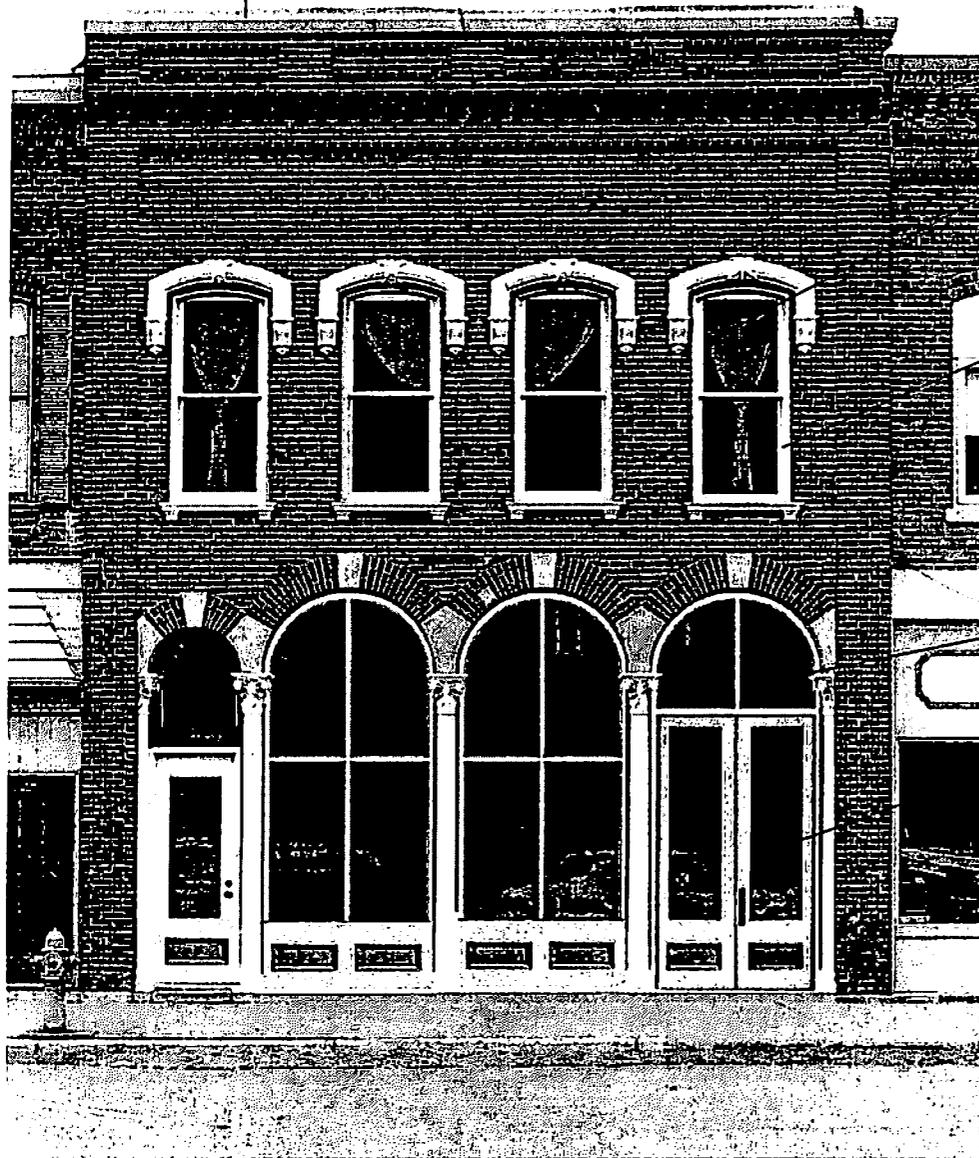
Inspect roofing and flashings

PROPOSED RENOVATION

**Tuckpoint and repair brick
as necessary**

**Repair existing windows or replace with
full-size insulated double-hung,
two-over-two windows**

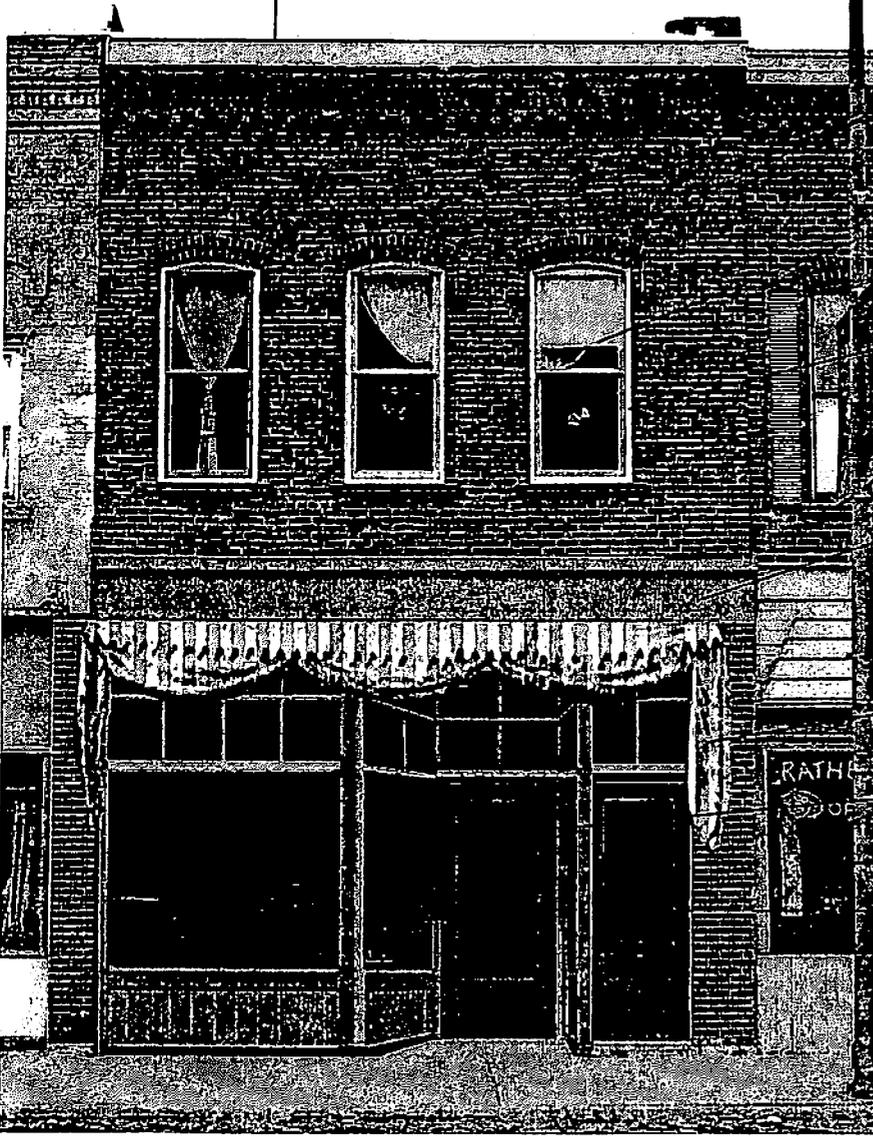
PROPOSED RENOVATION

Inspect roofing and flashings

Tuckpoint and repair brick as necessary

Repair existing windows or replace with insulated double-hung, two-over-two windows

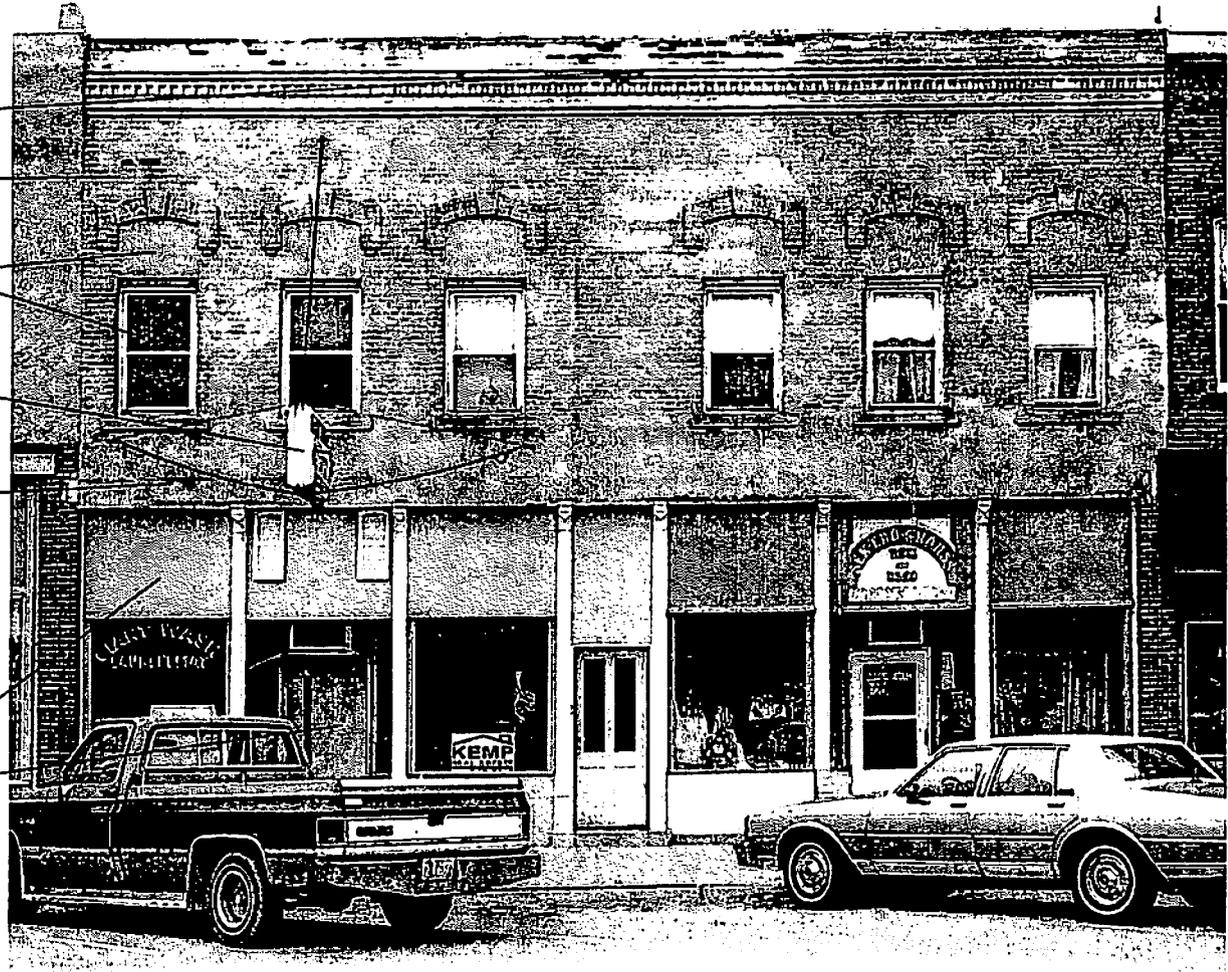
The transoms have been covered with modern panels

All three entry doors are of a different design

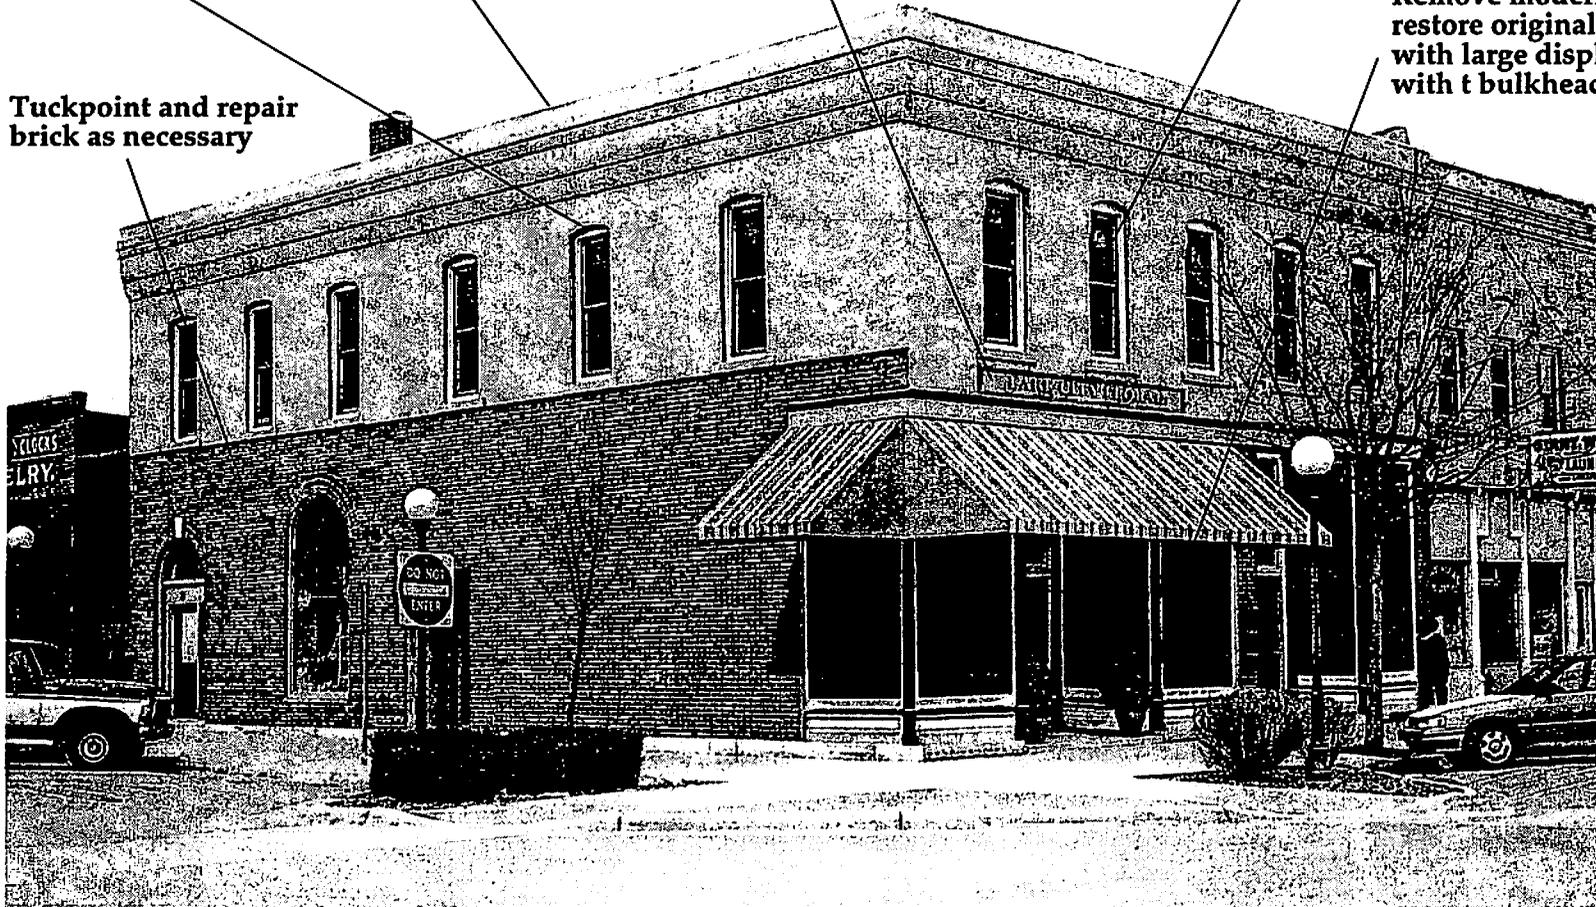
PROPOSED RENOVATION

Inspect roofing and flashings

Remove modern infill and restore original storefronts with large display windows with t bulkhead below

Tuckpoint and repair brick as necessary

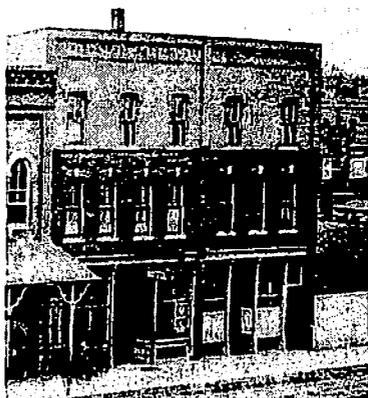
220-222 South Washington Merchants' Hotel

This three-story building was constructed with a brick facade in the early 1880s. The property served as a dry goods store at the pedestrian level and as a hotel above. From an early photograph it appears that the third story was added sometime after the construction of the first two floors.

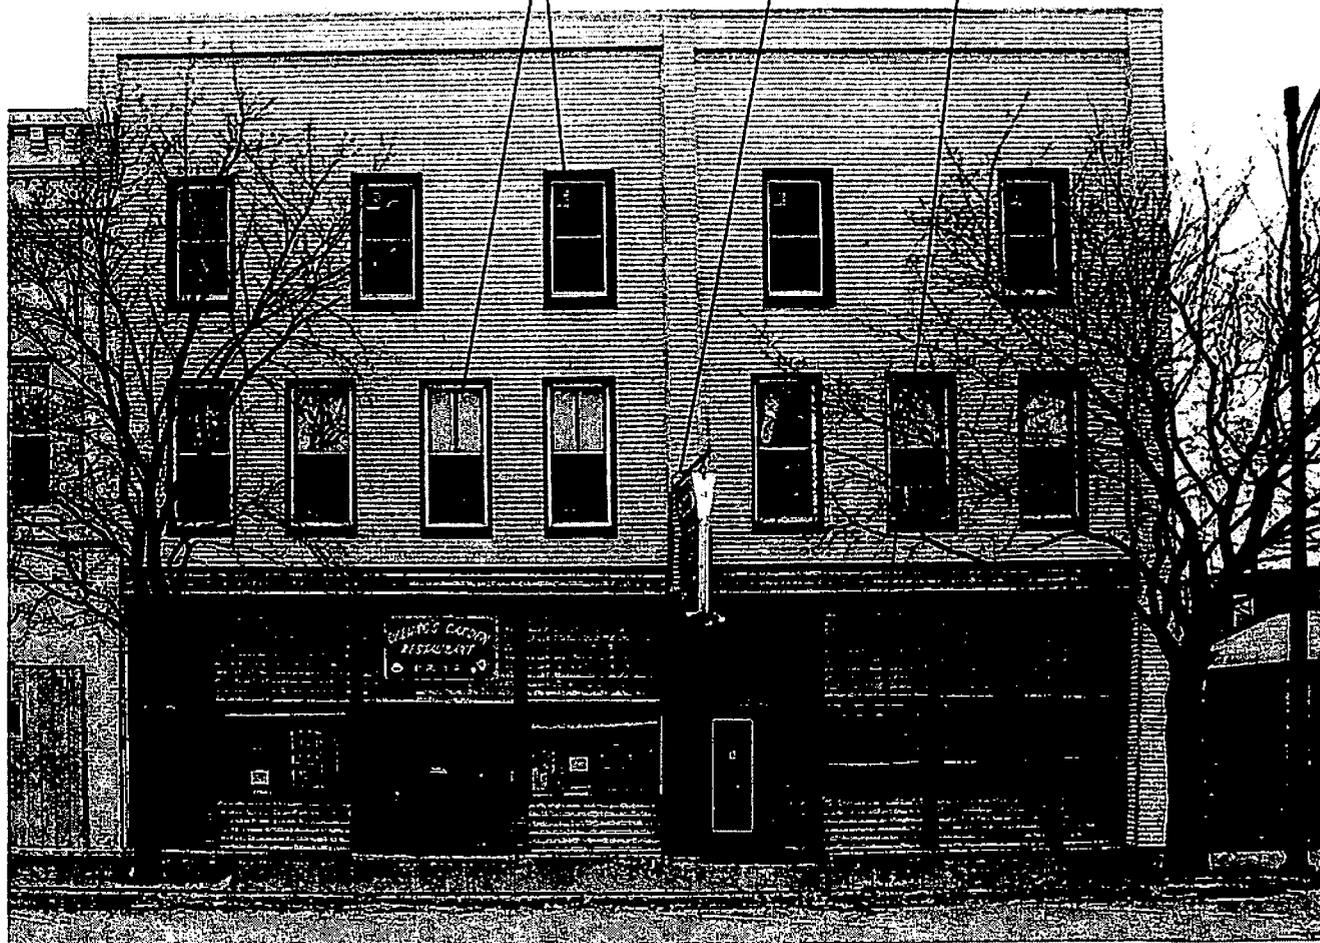
EXISTING CONDITION

The original brick facade has been covered with artificial siding

The building displays an inappropriate projecting backlit sign.

The storefront retains its original framing but the openings have been severely modified with down-sized horizontal window, and artificial siding covering the upper opening and bulkhead below

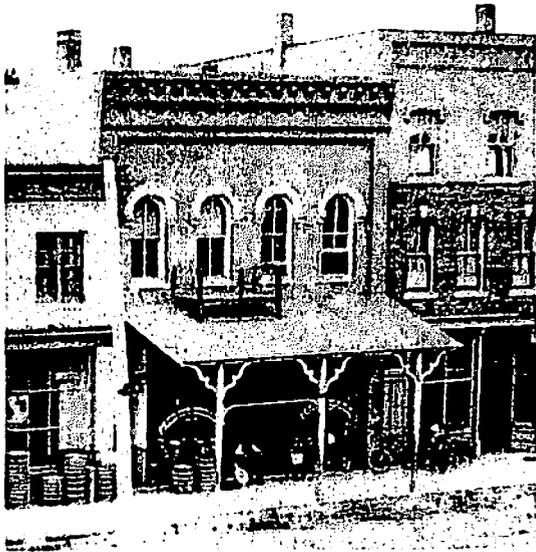
224 South Washington Rueckert Hardware

Built in the early 1870s to early 1880s,
by German immigrant Fred M. Rueckert, the
structure originally housed his hardware store.
The upper level was designed
for residential use.

The brick facade of this building has been partially covered in stucco.

The building displays an inappropriate projecting, backlit sign

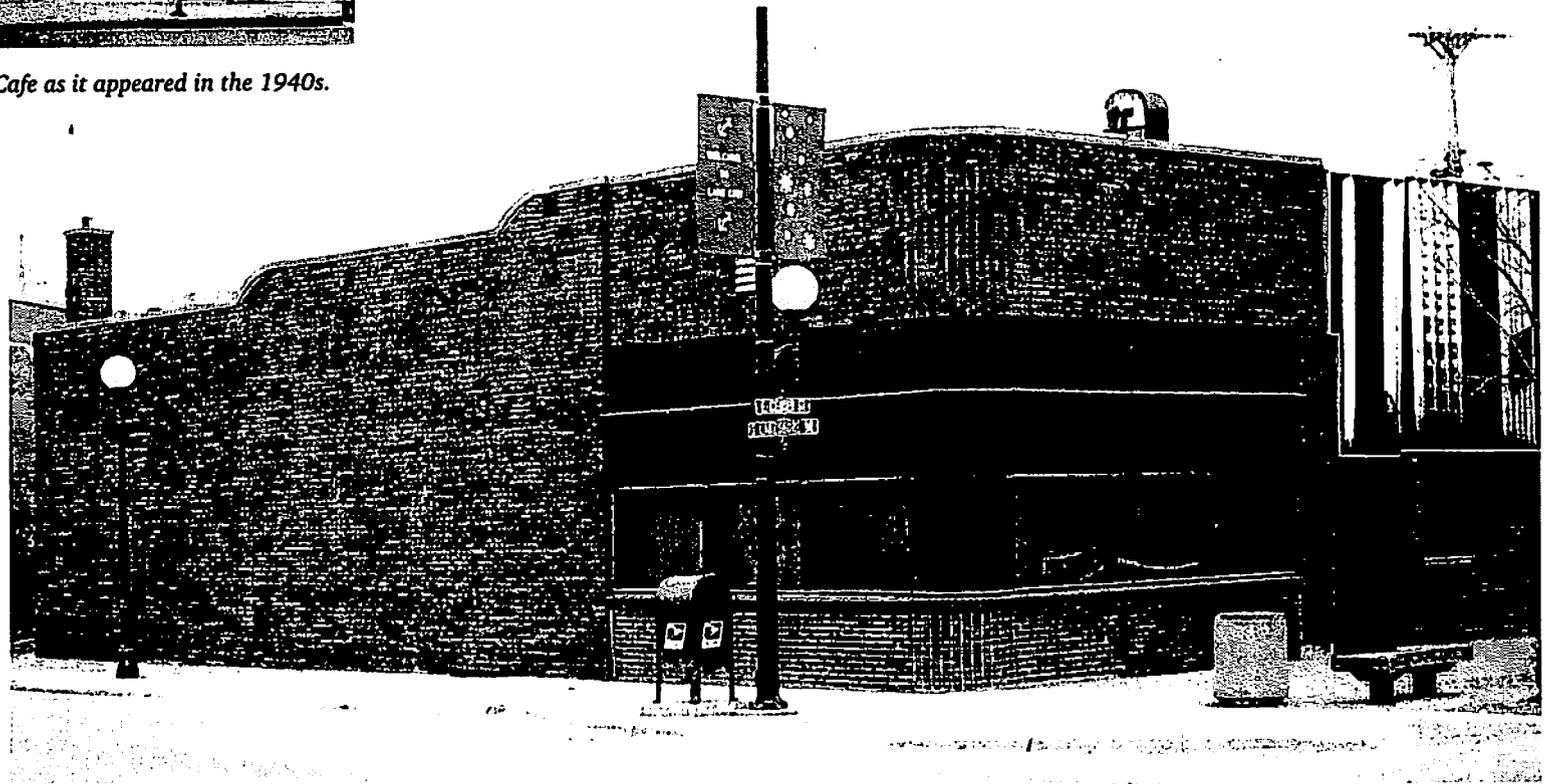
The original storefront with corner entrance was totally removed and replaced with a horizontal band of windows and brick bulkhead

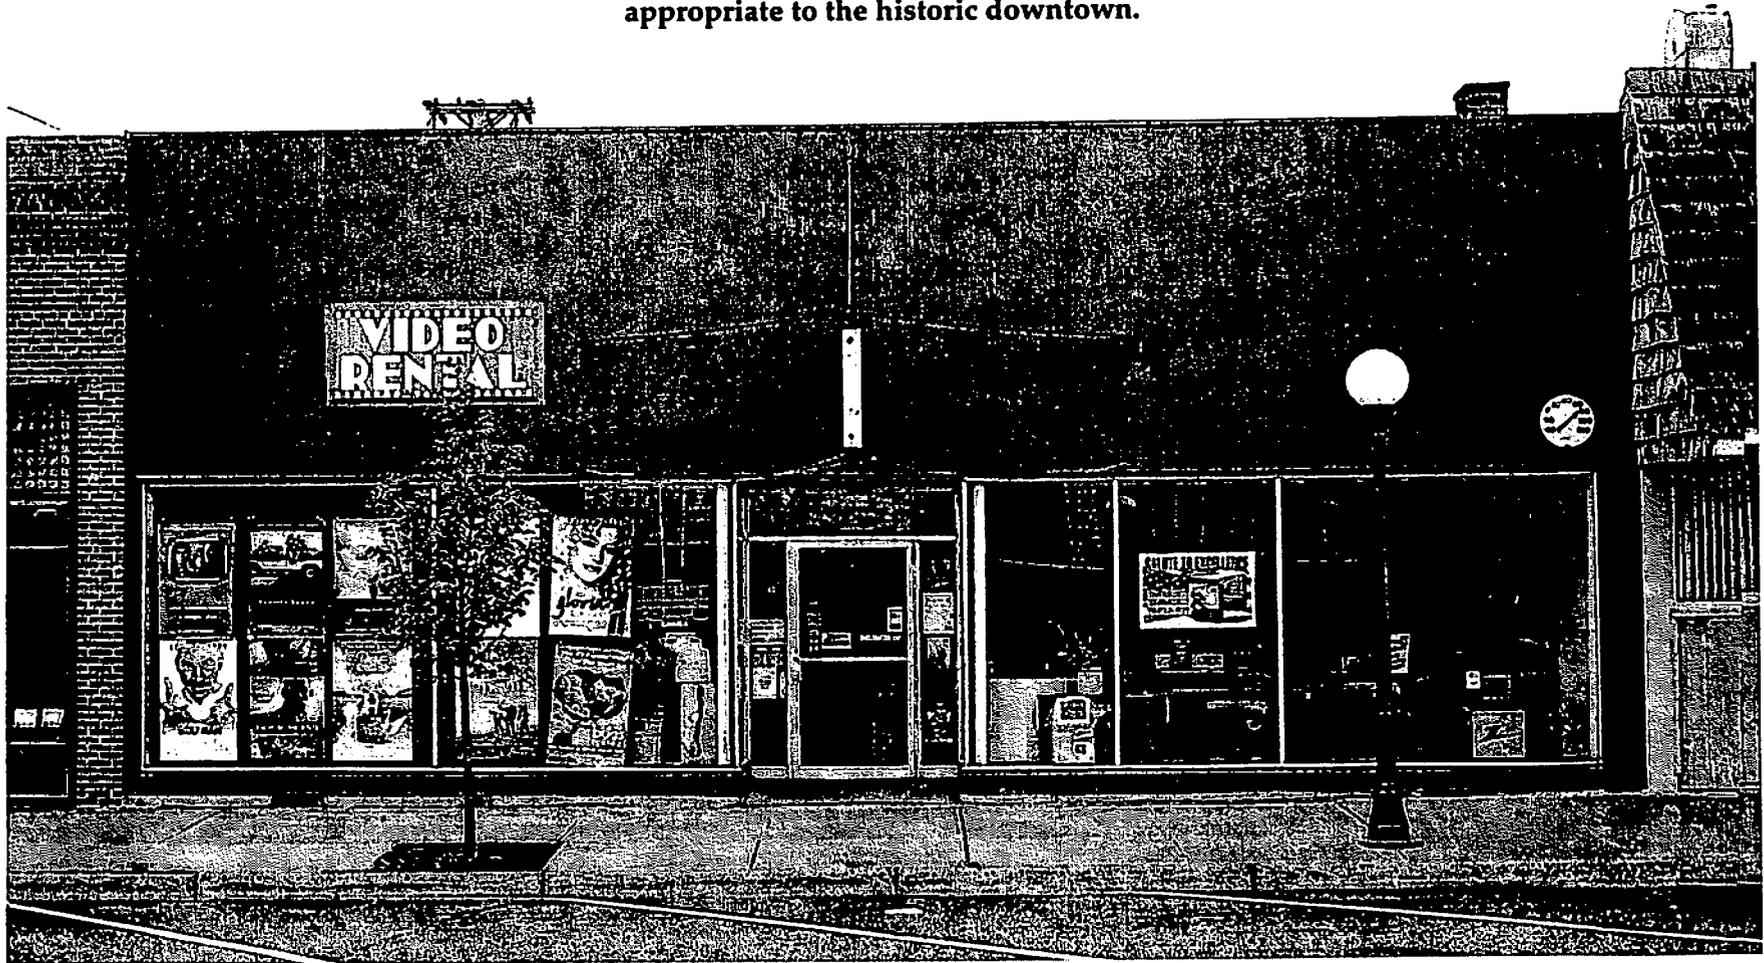
The storefront has totally been covered with modern vertical siding, and the original display windows and bulkhead replaced with oversized plate-glass windows. The projecting and backlit signage should be replaced with signs more appropriate to the historic downtown.

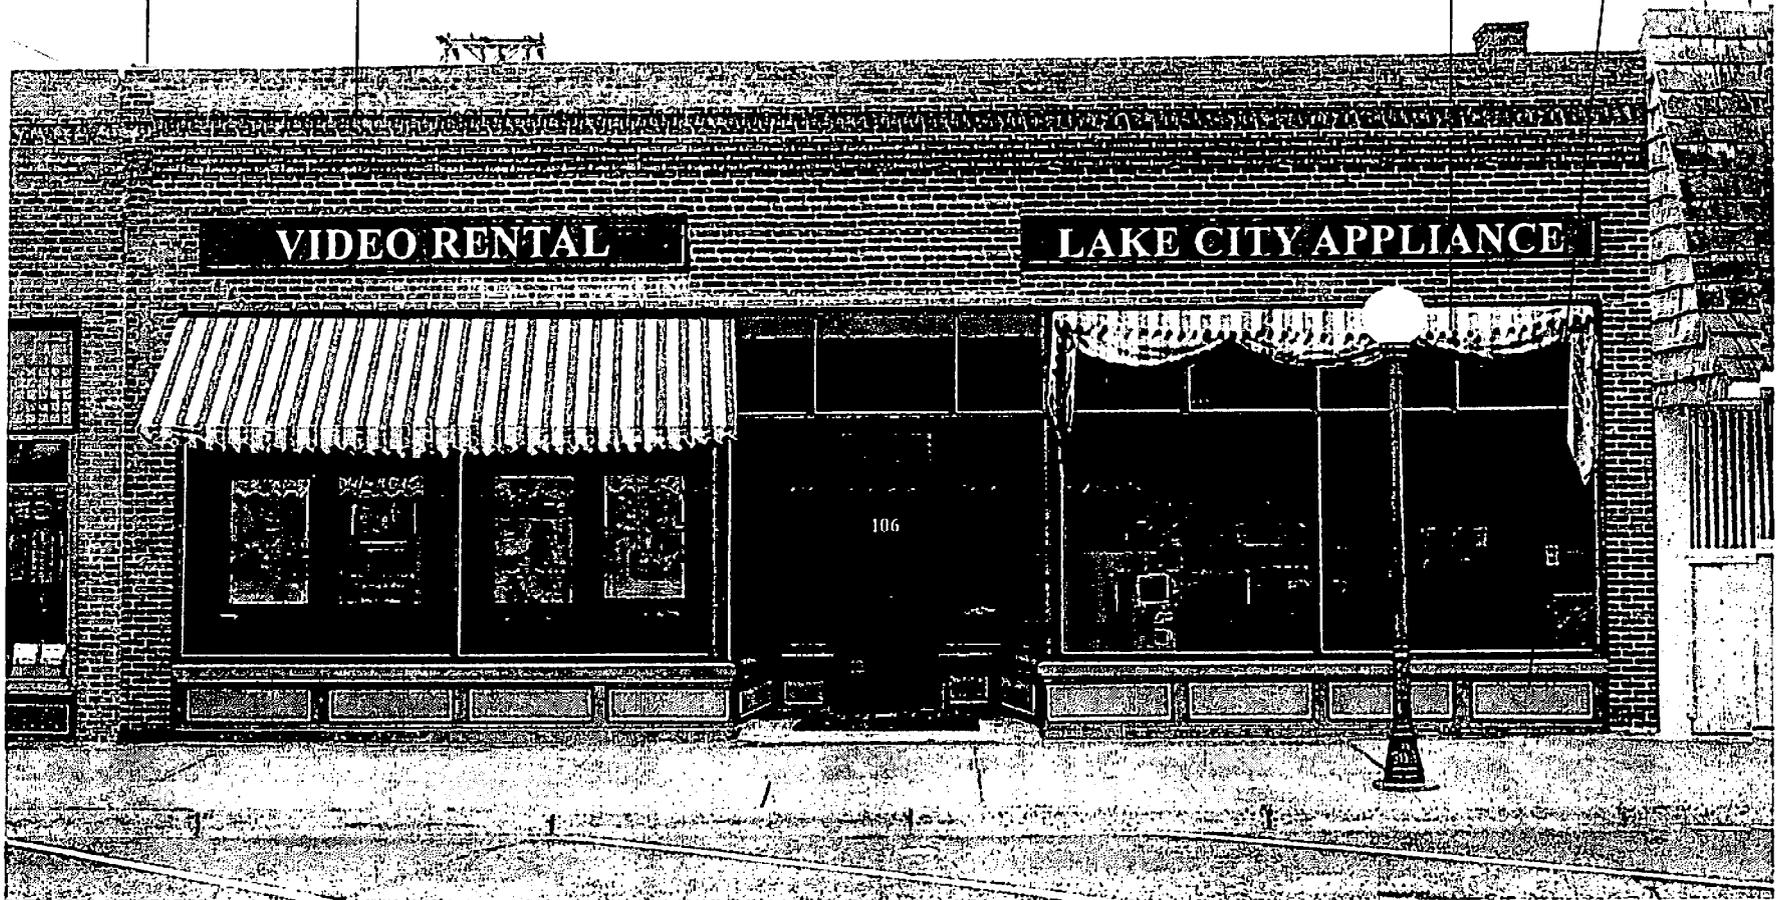
While the original design of this single-story commercial building is completely covered and/or replaced with modern elements, its proportions and scale relate to the neighboring buildings on Center Street.

Tuckpoint and repair brick
as necessary

Replace with large glass
display windows, and doors with
transom above and bulkhead below

Paint window trim and
storefront doors with
historic paint colors

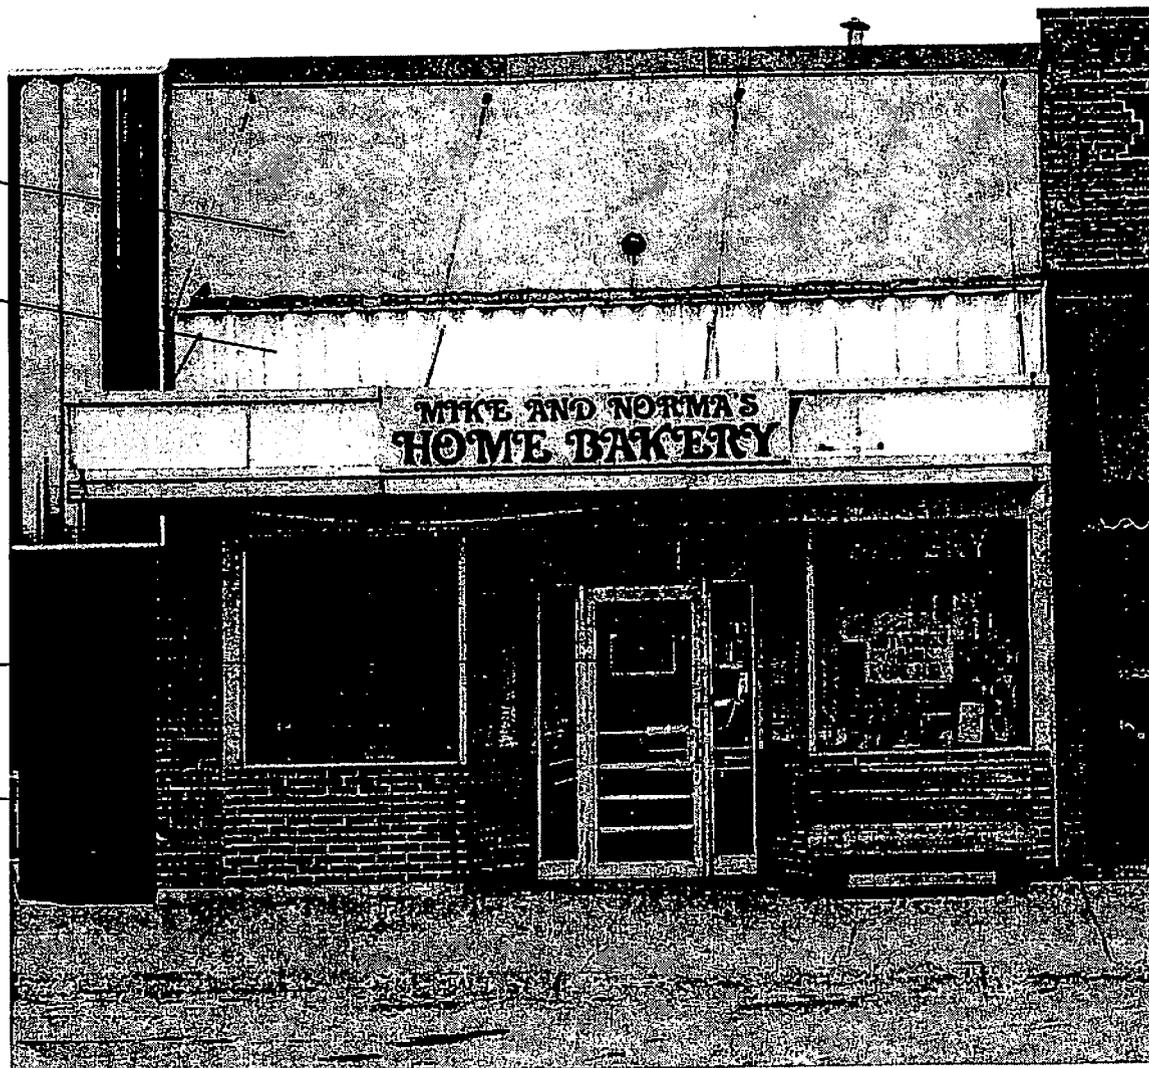
EXISTING CONDITION

The original door has been replaced with a commercial aluminum/glass door

The bulkhead have been removed and infilled with modern brick

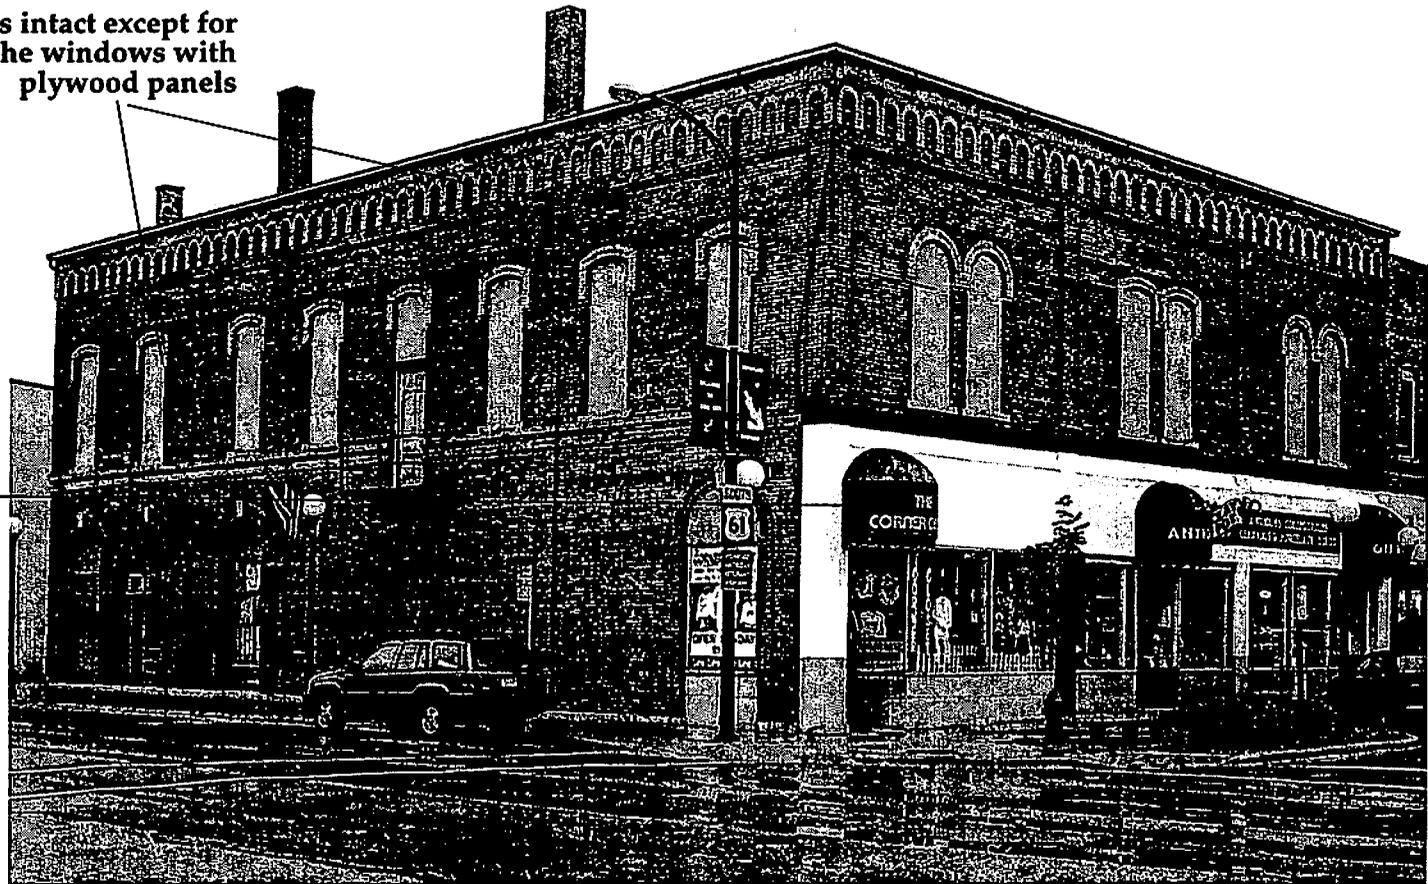
EXISTING CONDITION

The storefront has been modified with modern siding, and the original arched display windows and bulkhead replaced with down-sized display windows

The entry doors are crowned with inappropriate awnings

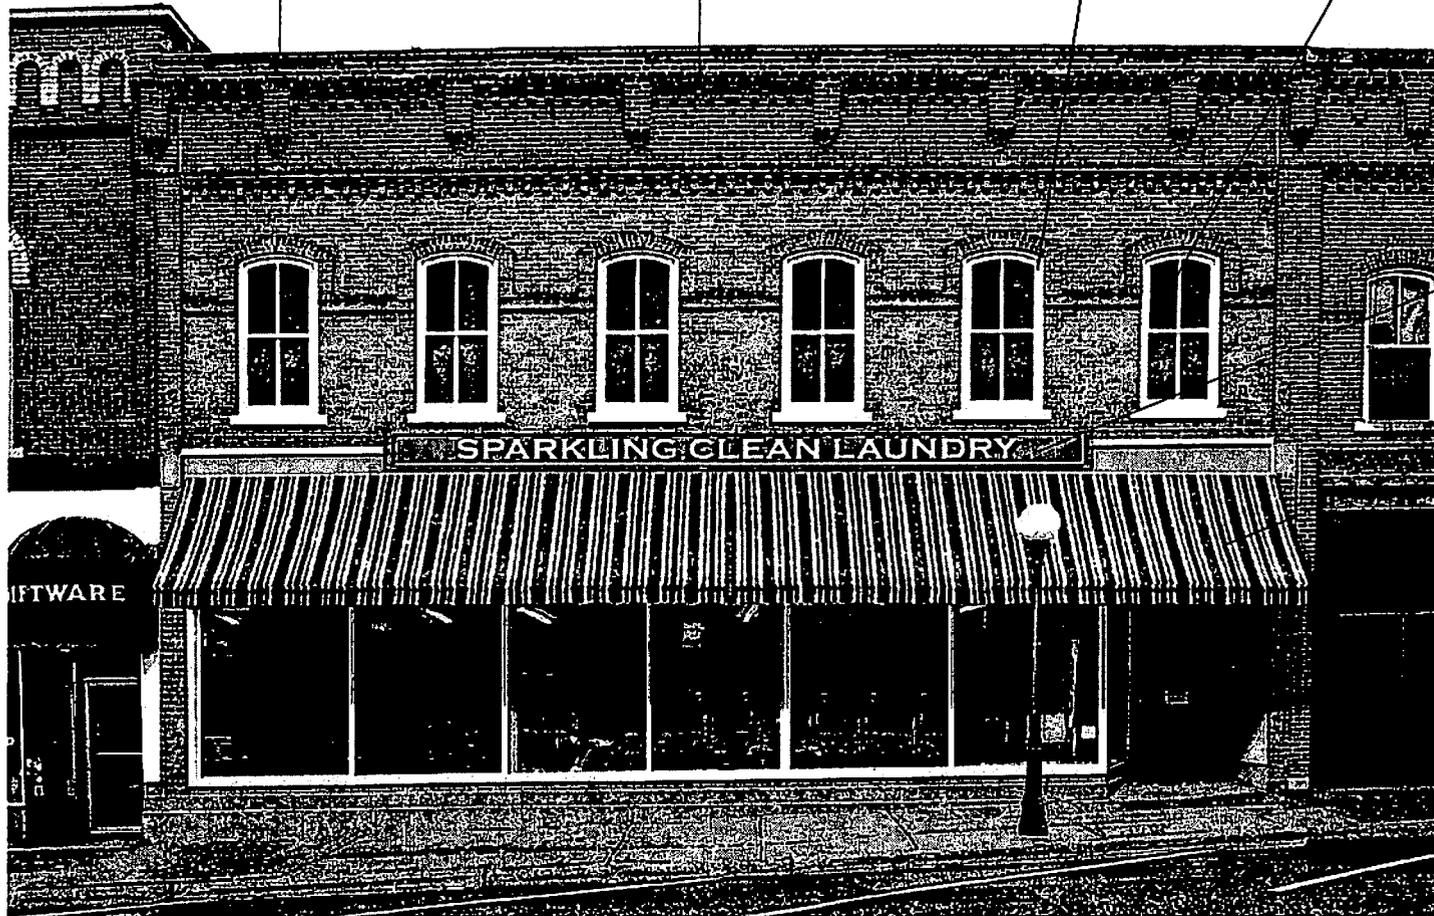
The storefront, like the adjacent Opera House, has been modified with modern siding, and the original arched display windows and bulkhead replaced with downsized display windows

Tuckpoint and repair brick as necessary

Repair, clean and repaint window trim

Repair or replace upper windows with full-size, insulated double-hung, two-over-two windows

Place commercial signage on a flush signboard over the arched storefront

Add canvas awnings as originally designed

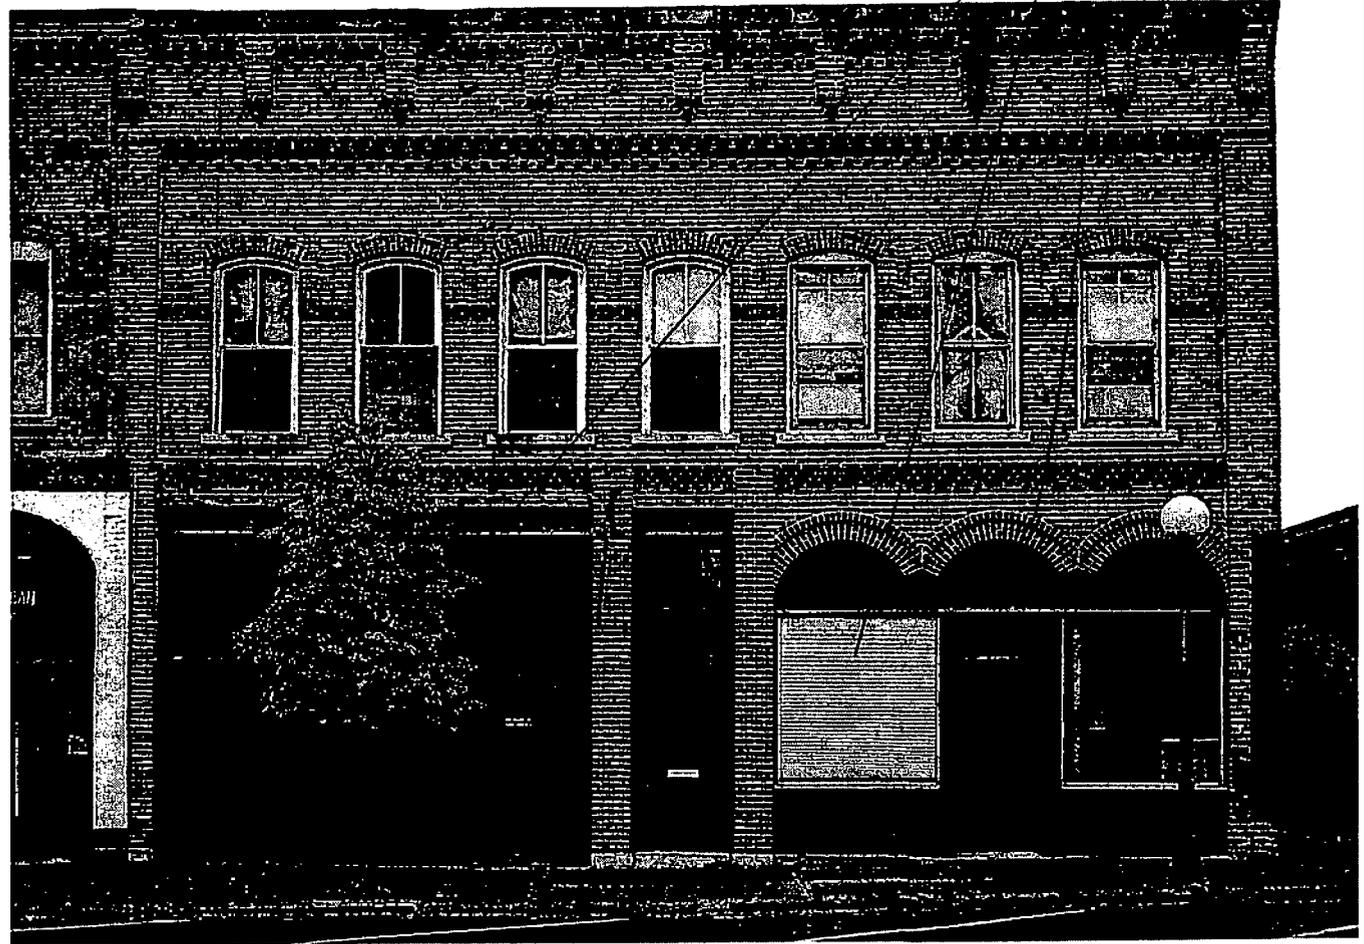
EXISTING CONDITION

The upper story remains intact with its original two-over-two windows

The storefronts have been modified with vertical siding infill and the display windows downsized

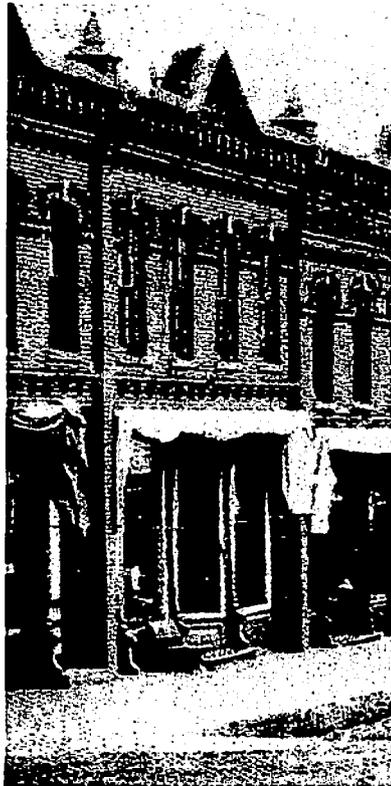
120 West Center Street The Edward Wise Block

Constructed in 1893, the upper story of this ornate brick building retains most of its architectural ornamentation. While the storefront retains its original cast-iron columns, the infill has been dramatically modified with modern elements in stark contrast to the refinement above.

The upper story windows have been down-sized with vertical siding above

The storefront has been severally modified with oversized transom windows and brick infill

Inspect, clean and repair the decorative cornice as necessary

Tuckpoint and repair brick as necessary

Repair or replace upper windows with full-size, insulated double-hung, one-over-one windows

Repair, clean and repaint window trim

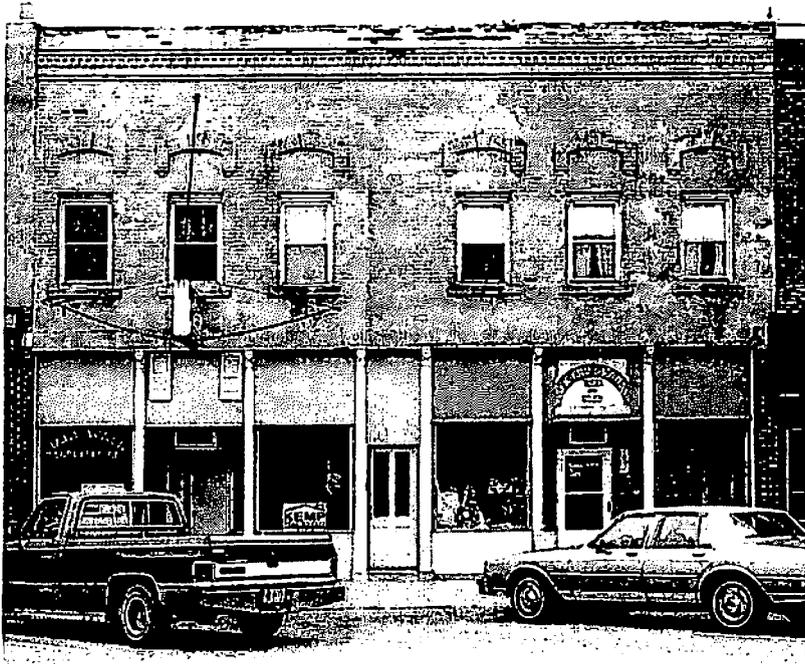
- Building has downsized upper-story windows
- The upper-story brick is in need of repair and cleaning
- The building displays a variety of confusing signage
- The transom above the display windows has been infilled
- Modern windows and doors have replaced the original

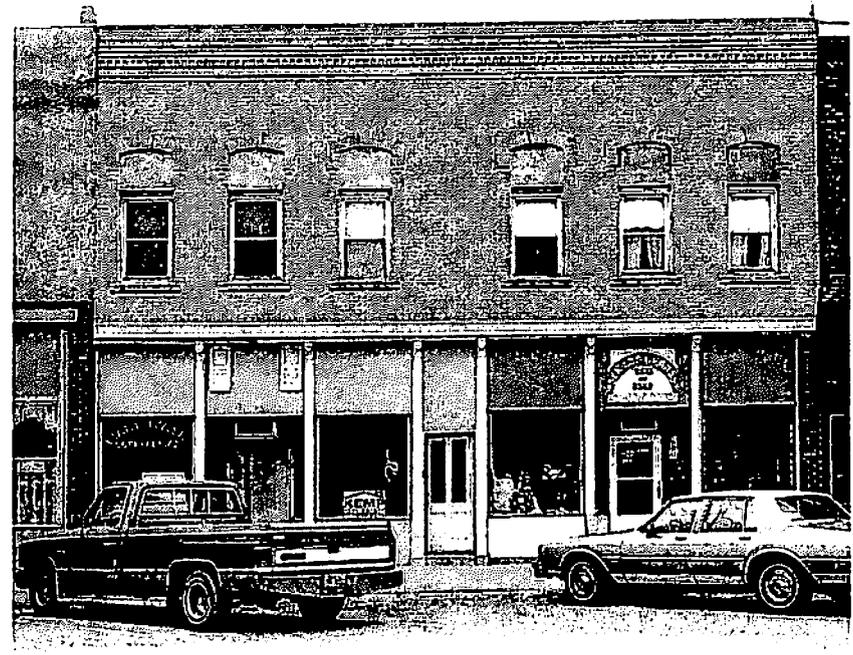
Phase 1

- This phase may be as simple as:
 - Repairing and cleaning the brick on the upper story
 - Removing the projecting, backlit plastic sign

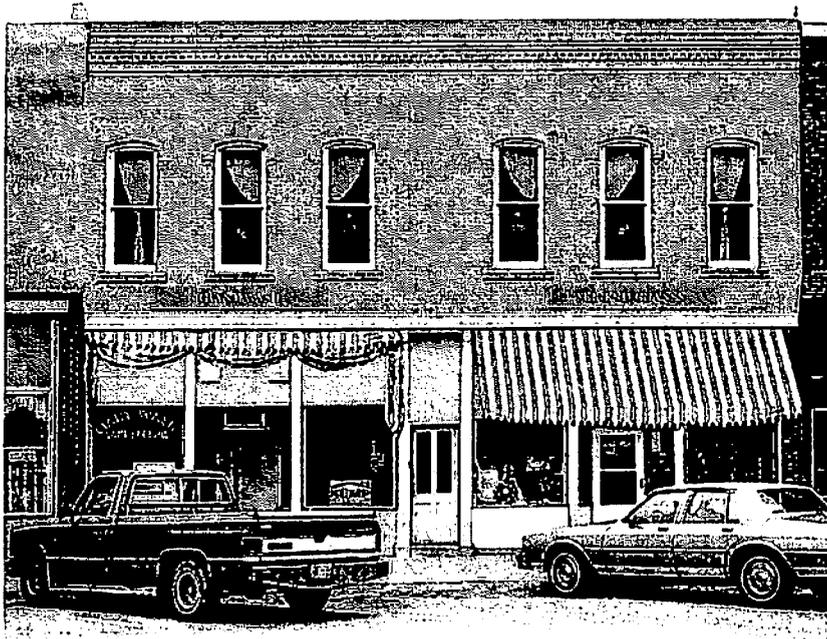
Phase 2

Removing the infill in the upper-story opening and replacing the one-over-one double-hung windows
Adding appropriate signage on signboards above the storefronts
Adding retractable canvas awnings
