City of Lake City Downtown Preservation Design Manual

Prepared for
The Lake City Heritage Preservation Commission

Thomas R. Zahn & Associates
Fall 1989

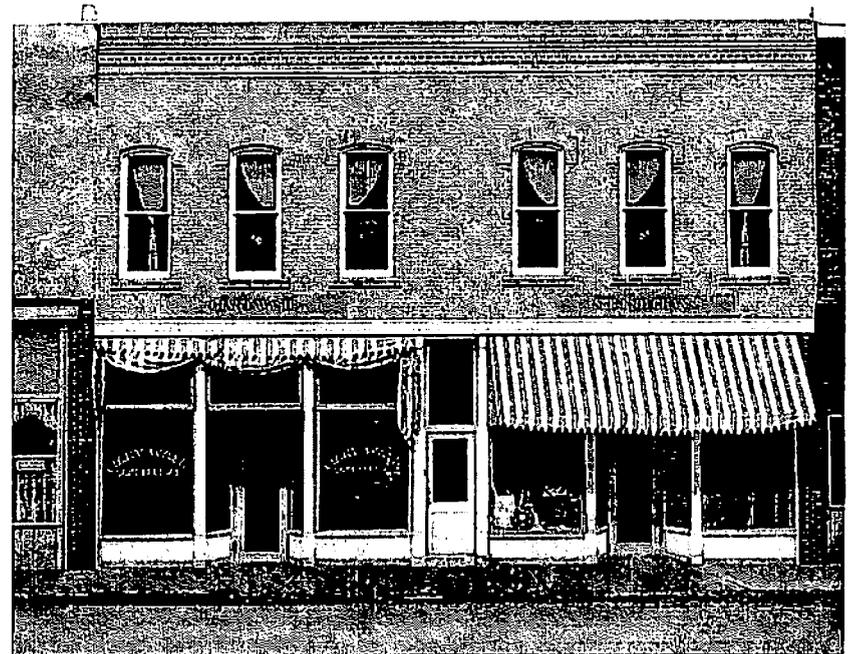
Phase 3

Removing the air conditioning units over the entries
Repairing and replacing the storefront with appropriate doors, display windows and transoms above.
