# **Feasibility Study**

## **Public Safety Facility**

**Police - Emergency Medical Services  
Emergency Operations Center**

**Report to City Council  
January 4<sup>th</sup>, 2016**

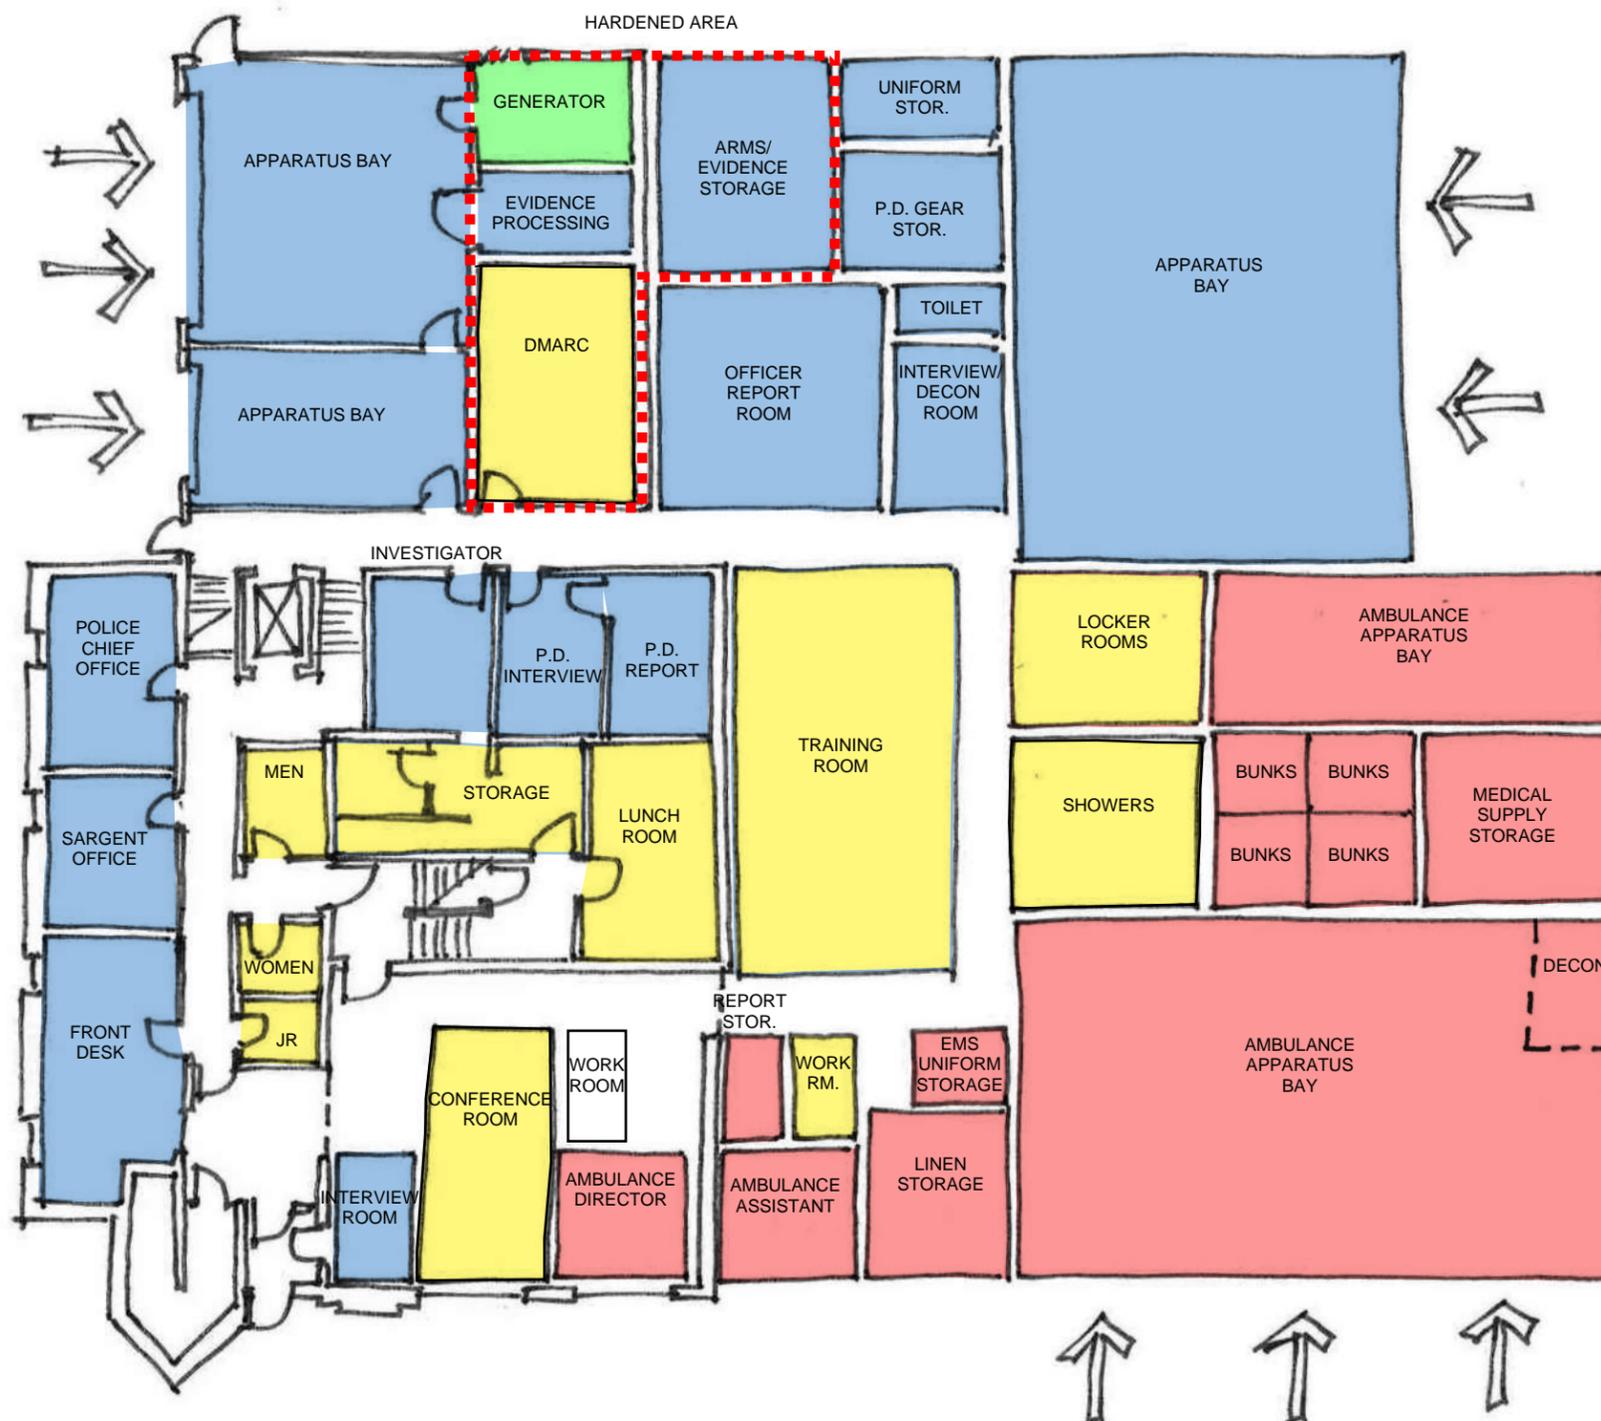
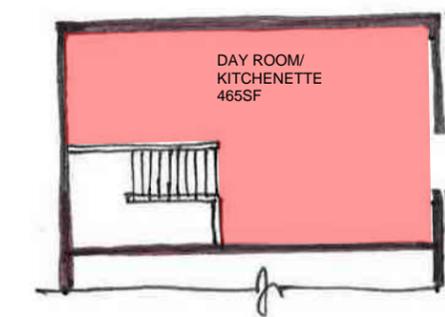
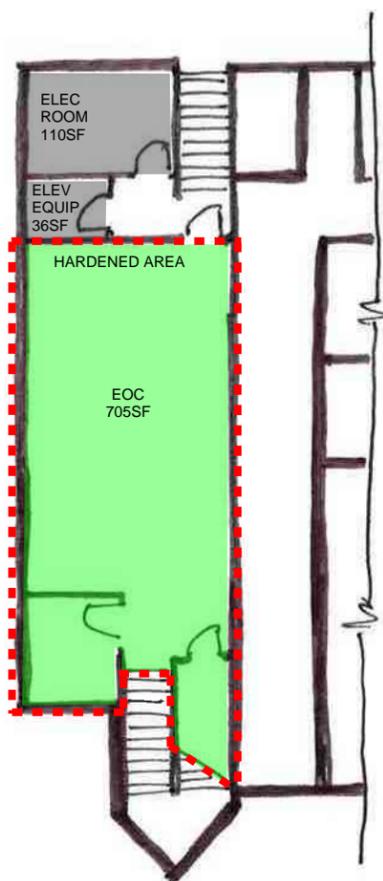
**LAKE CITY FEASIBILITY STUDY - OPTION A: REMODELING/ADDITION POLICE DEPARTMENT/EOC/EMS**

SF AREA
ARMS/EVIDENCE - ADDITION	252
PD OFFICES: CHIEF, INVESTIGATOR, SARGENT	455
FRONT OFFICE STAFF	276
PD GEAR STORAGE - ADDITION	140
INTERVIEW/DECON ROOM - ADDITION	150
EVIDENCE PROCESSING	91
INTERVIEW ROOM	72
P.D. INTERVIEW ROOM	126
TOILET ROOMS - ADDITION	36
OFFICERS' REPORT AREA - ADDITION	361
APPARATUS BAY - ADDITION	1,496
APPARATUS BAY	625
APPARATUS BAY - SALLY PORT	375
UNIFORM STORAGE - ADDITION	98
PD REPORT STORAGE	126
<b>TOTAL</b>	<b>4,679</b>
EOC/KITCHENETTE/TOILET ROOMS	705
GENERATOR ROOM	126
<b>TOTAL</b>	<b>831</b>
TOILET ROOMS	90
JANITOR ROOM	35
LUNCH ROOM	200
STORAGE	140
TRAINING ROOM	684
CONFERENCE ROOM	248
DMARC ROOM	280
LOCKER ROOM - ADDITION	208
SHOWERS	240
<b>TOTAL</b>	<b>2,125</b>
EMS AMBULANCE DIRECTOR'S OFFICE	121
EMS AMBULANCE ASSISTANT - ADDITION	132
BUNK ROOMS - ADDITION	306
DAY ROOM/KITCHENETTE	465
LINEN STORAGE/MEDICAL SUPPLIES - ADDITION	408
REPORT STORAGE - ADDITION	50
EMS WORKROOM/MAIL - ADDITION	50

EMS UNIFORM STORAGE - ADDITION	50
AMBULANCE VEHICLE BAY/DECONTAMINATION AREA - ADDITION	2,106
<b>TOTAL</b>	<b>3,688</b>
ELECTRICAL ROOM	110
ELEVATOR EQUIP ROOM	36
<b>TOTAL</b>	<b>146</b>
EXISTING BUILDING CIRCULATION	2,591
BUILDING ADDITION CIRCULATION	1,015
<b>TOTAL BUILDING AREA</b>	<b>15,075</b>
Remodeled Exist. Total	7,347
Addition Total	7,728
<b>TOTAL BUILDING AREA</b>	<b>15,075</b>

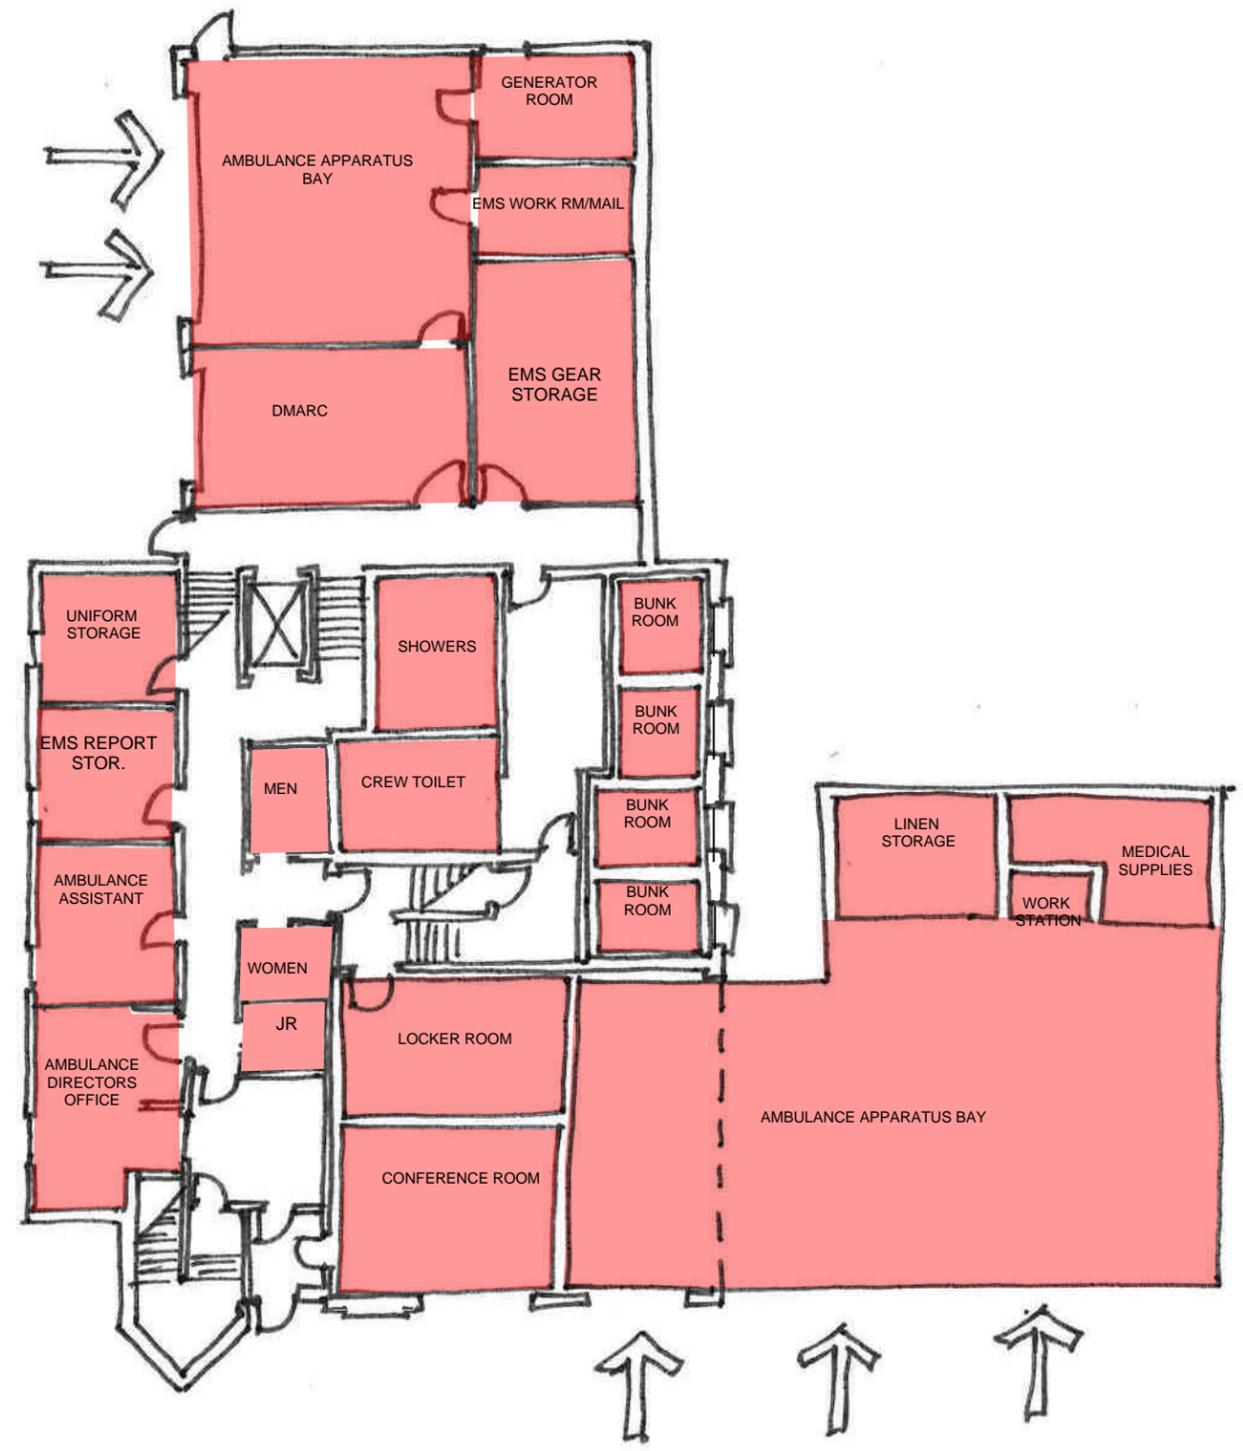
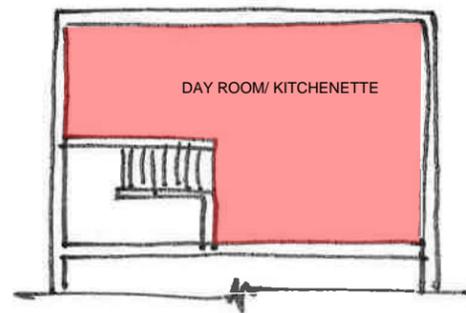
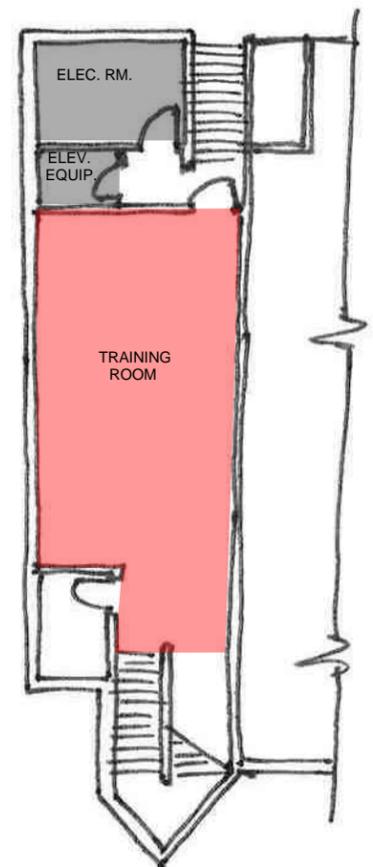
SF AREA
EMS OFFICES: DIRECTOR, ASSISTANT	357
DMARC	375
BUNK ROOMS	320
EMS CREW TOILET ROOMS	225
DAY ROOM/KITCHENETTE	465
LINEN STORAGE/MEDICAL SUPPLIES - ADDITION	350
EMS WORKROOM/MAIL	106
EMS GEAR STORAGE	294
EMS REPORT STORAGE	132
EMS UNIFORM STORAGE	130
AMBULANCE APPARATUS BAY - ADDITION	1,381
AMBULANCE APPARATUS BAY	1,003
CONFERENCE	316
LOCKER ROOM	260
TRAINING ROOM	705
TOILET ROOMS	90
JANITOR	35
GENERATOR	126
SHOWERS	110
WORK STATION	28
<b>TOTAL</b>	<b>6,808</b>
ELECTRICAL ROOM	110
ELEVATOR EQUIP ROOM	36
<b>TOTAL</b>	<b>146</b>
EXISTING BUILDING CIRCULATION	2,368
BUILDING ADDITION CIRCULATION	264
<b>TOTAL BUILDING AREA</b>	<b>9,586</b>
Remodeled Exist. Total	7,347
Addition Total	2,239
<b>TOTAL BUILDING AREA</b>	<b>9,586</b>

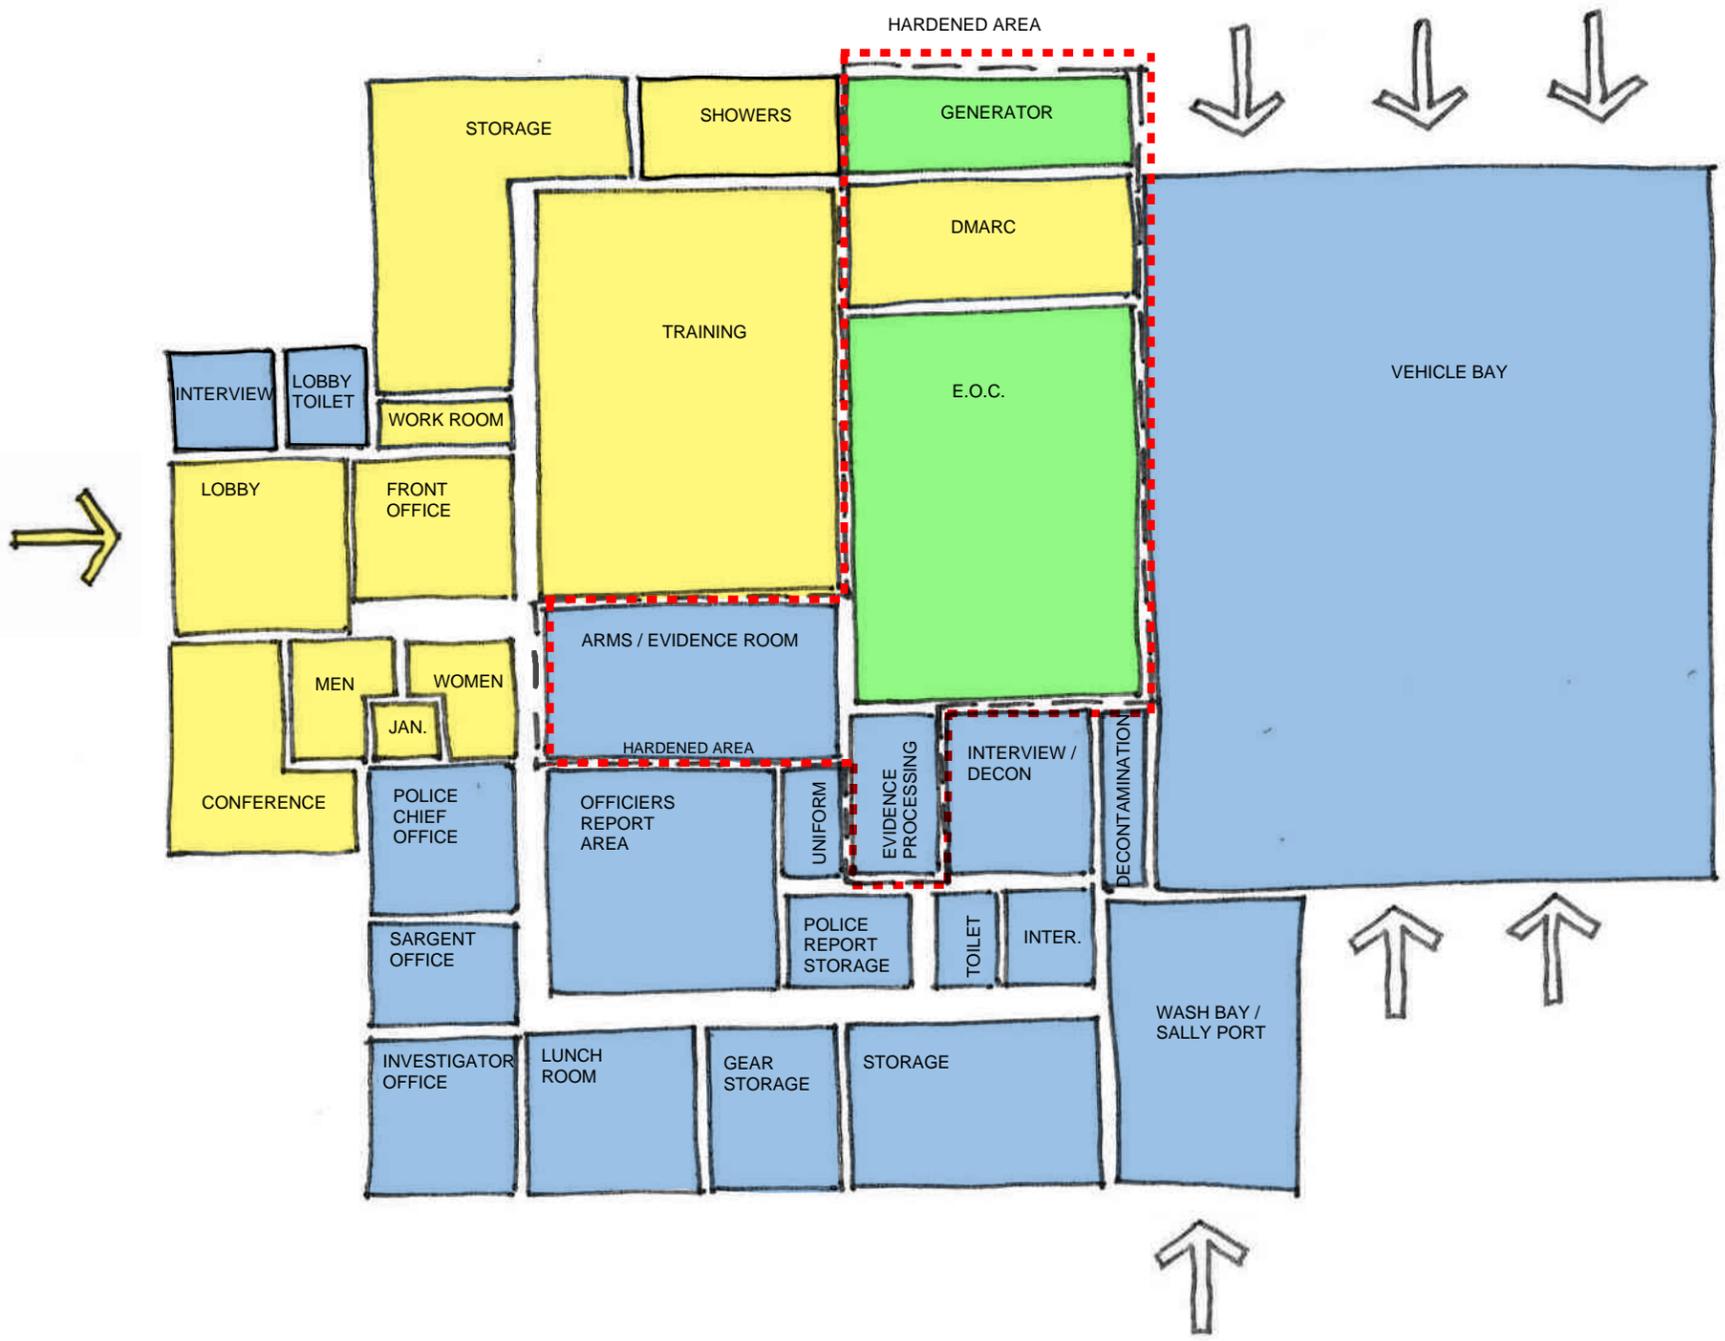
SF AREA
ARMS/EVIDENCE	338
PD OFFICES: CHIEF, INVESTIGATOR, SARGENT	455
PD GEAR STORAGE	154
PD UNIFORM STORAGE	50
INTERVIEW/DECON ROOM	182
EVIDENCE PROCESSING	112
INTERVIEW ROOM	64
TOILET ROOM	48
OFFICERS' REPORT AREA	380
LUNCH ROOM	210
STORAGE	330
PD REPORT STORAGE	88
VEHICLE STORAGE BAY/WASH BAY/SALLY PORT	3,422
DECONTAMINATION	60
LOBBY TOILET ROOM	60
LOBBY INTERVIEW ROOM	100
<b>TOTAL</b>	<b>6,053</b>
EOC/KITCHENETTE/TOILET ROOMS	875
GENERATOR ROOM	180
<b>TOTAL</b>	<b>1,055</b>
DMARC	240
LOBBY	225
FRONT OFFICE AND WORKROOM	216
TRAINING ROOM	910
TOILET ROOMS	180
STORAGE	423
JANITOR ROOM	30
CONFERENCE ROOM	234
SHOWERS	136
<b>TOTAL</b>	<b>2,594</b>
<b>TOTAL BUILDING AREA</b>	<b>9,702</b>
BUILDING CIRCULATION	1,455
<b>TOTAL BUILDING AREA</b>	<b>11,157</b>

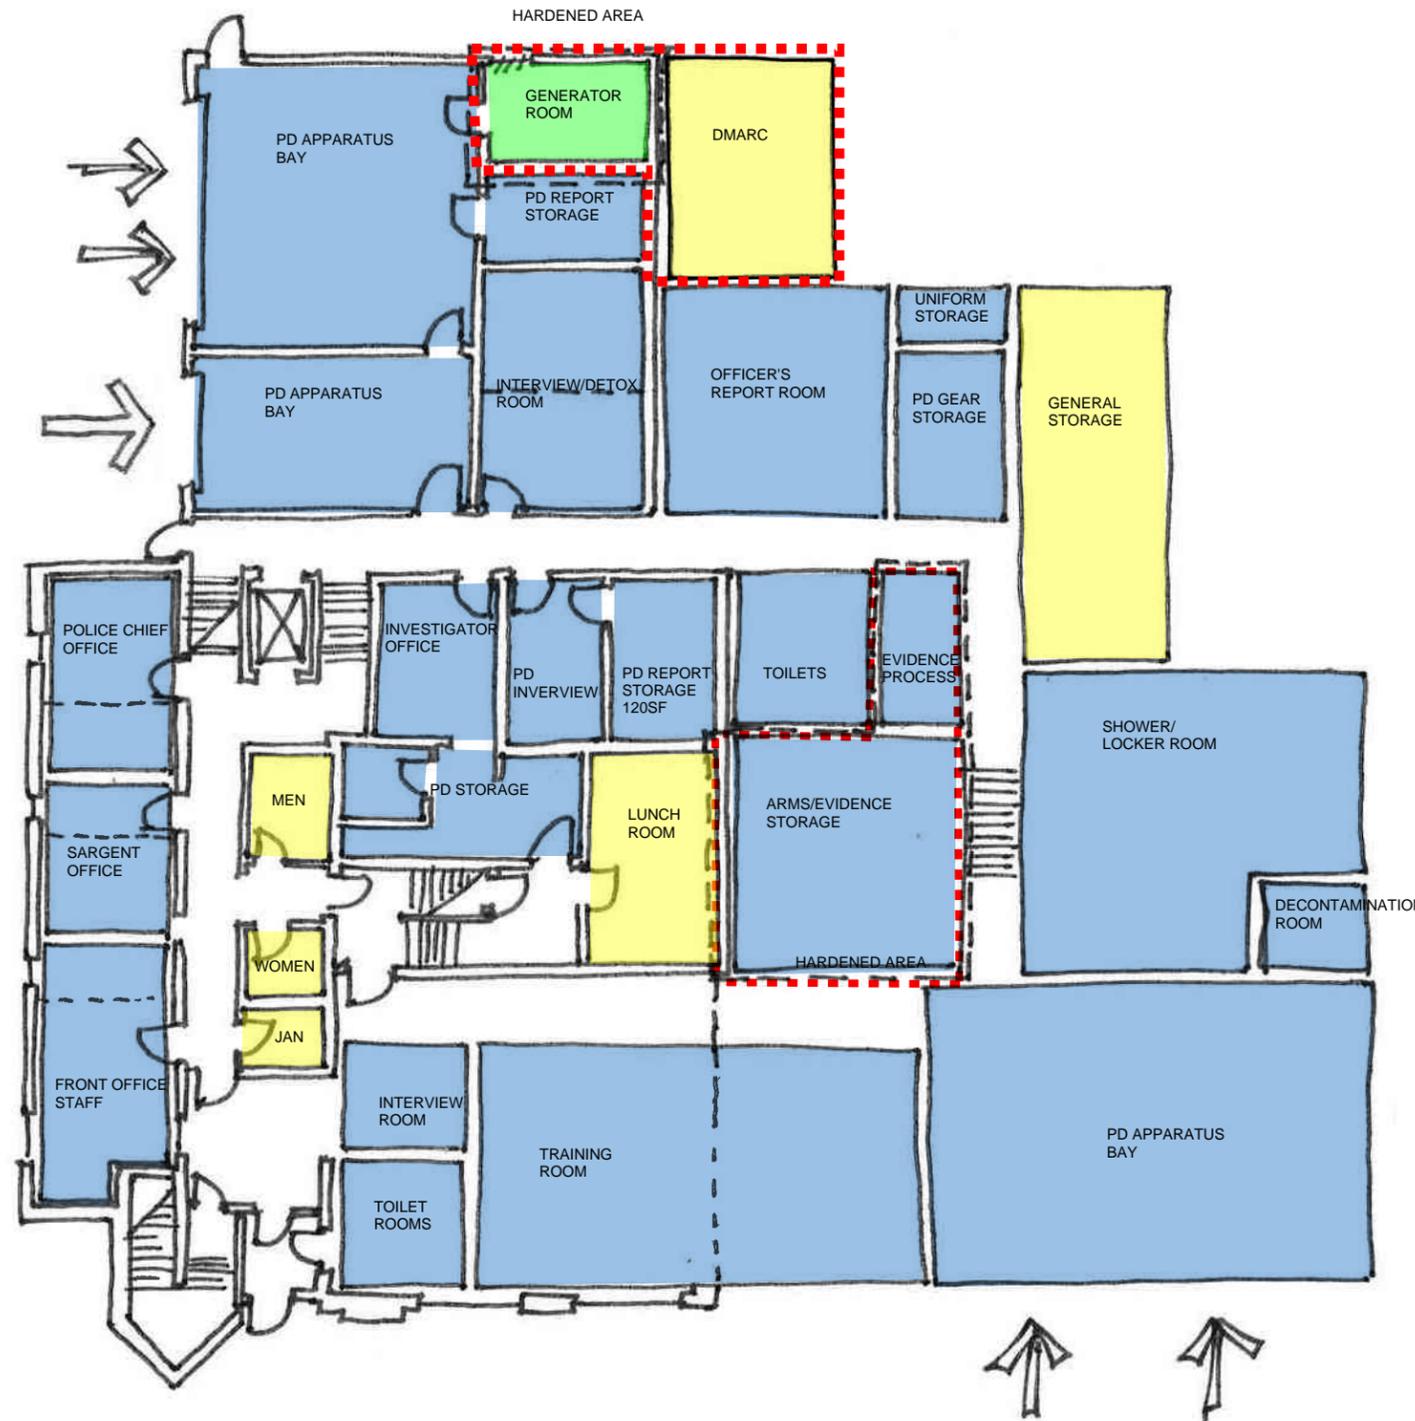
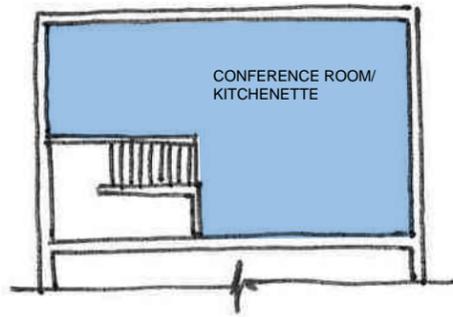
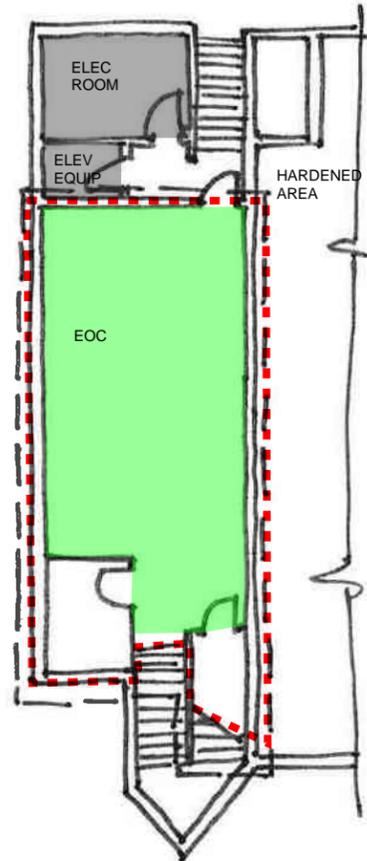
**LAKE CITY FEASIBILITY STUDY - OPTION C: REMODELING/ADDITION POLICE DEPARTMENT/EOC**

SF AREA
ARMS/EVIDENCE	380
PD OFFICES: CHIEF, INVESTIGATOR, SARGENT	455
FRONT OFFICE STAFF	276
PD GEAR STORAGE - ADDITION	126
INTERVIEW/DECON ROOM - ADDITION	294
EVIDENCE PROCESSING	91
INTERVIEW ROOM	99
PD INTERVIEW ROOM	126
TOILET ROOM - ADDITION	156
TOILET ROOM	121
OFFICERS' REPORT AREA - ADDITION	400
PD APPARATUS BAY - ADDITION	1,088
PD APPARATUS BAY	625
PD APPARATUS BAY	375
STORAGE	106
UNIFORM STORAGE - ADDITION	45
PD REPORT STORAGE - ADDITION	126
TRAINING ROOM - ADDITION	378
TRAINING ROOM	441
CONFERENCE / KITCHENETTE	465
SHOWER/LOCKER ROOM/DECONTAMINATION	780
PD STORAGE	140
<b>TOTAL</b>	<b>7,093</b>
EOC/KITCHENETTE/TOILET ROOMS	705
GENERATOR ROOM	126
<b>TOTAL</b>	<b>831</b>
TOILET ROOMS	90
STORAGE - ADDITION	442
JANITOR ROOM	35
LUNCH ROOM	200
DMARC	285
<b>TOTAL</b>	<b>1,052</b>
ELECTRICAL ROOM	110
ELEVATOR EQUIP	36
<b>TOTAL</b>	<b>146</b>
EXISTING BUILDING CIRCULATION	2,368
BUILDING ADDITION CIRCULATION	610
<b>TOTAL BUILDING AREA</b>	<b>12,100</b>

Remodeled Exist. Total	7,347
Addition Total	4,753
<b>TOTAL BUILDING AREA</b>	<b>12,100</b>

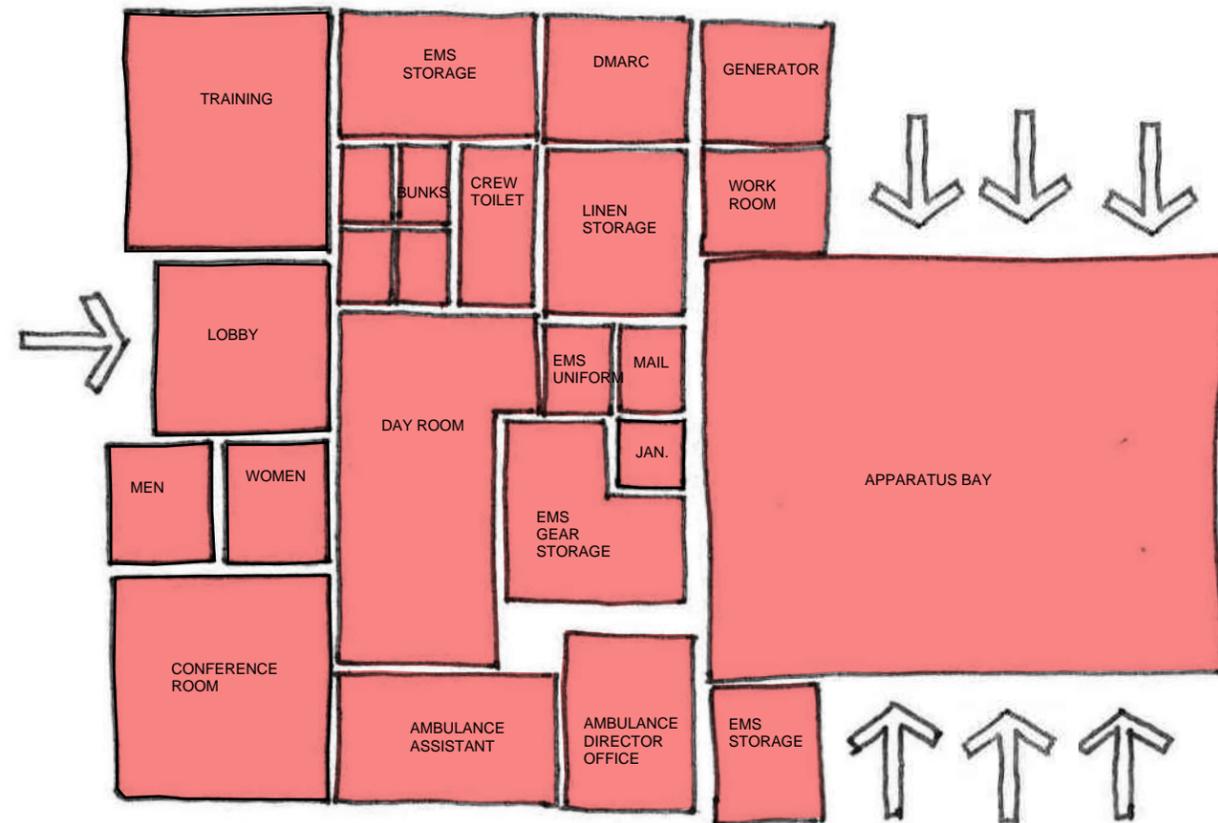
SF AREA
EMS OFFICES: DIRECTOR, ASSISTANT	374
EMS GEAR STORAGE	207
DMARC ROOM	132
BUNK ROOMS	140
EMS CREW TOILET ROOMS	98
DAY ROOM/KITCHENETTE	452
LINEN STORAGE/MEDICAL SUPPLIES	168
EMS WORKROOM/MAIL	144
EMS STORAGE	120
EMS UNIFORM STORAGE	48
EMS REPORT STORAGE	170
APPARATUS BAY	1,587
LOBBY	225
TRAINING ROOM	378
TOILET ROOMS	190
JANITOR ROOM	36
CONFERENCE ROOM	360
<b>TOTAL BUILDING AREA</b>	<b>4,829</b>
BUILDING CIRCULATION	724
<b>TOTAL BUILDING AREA</b>	<b>5,553</b>

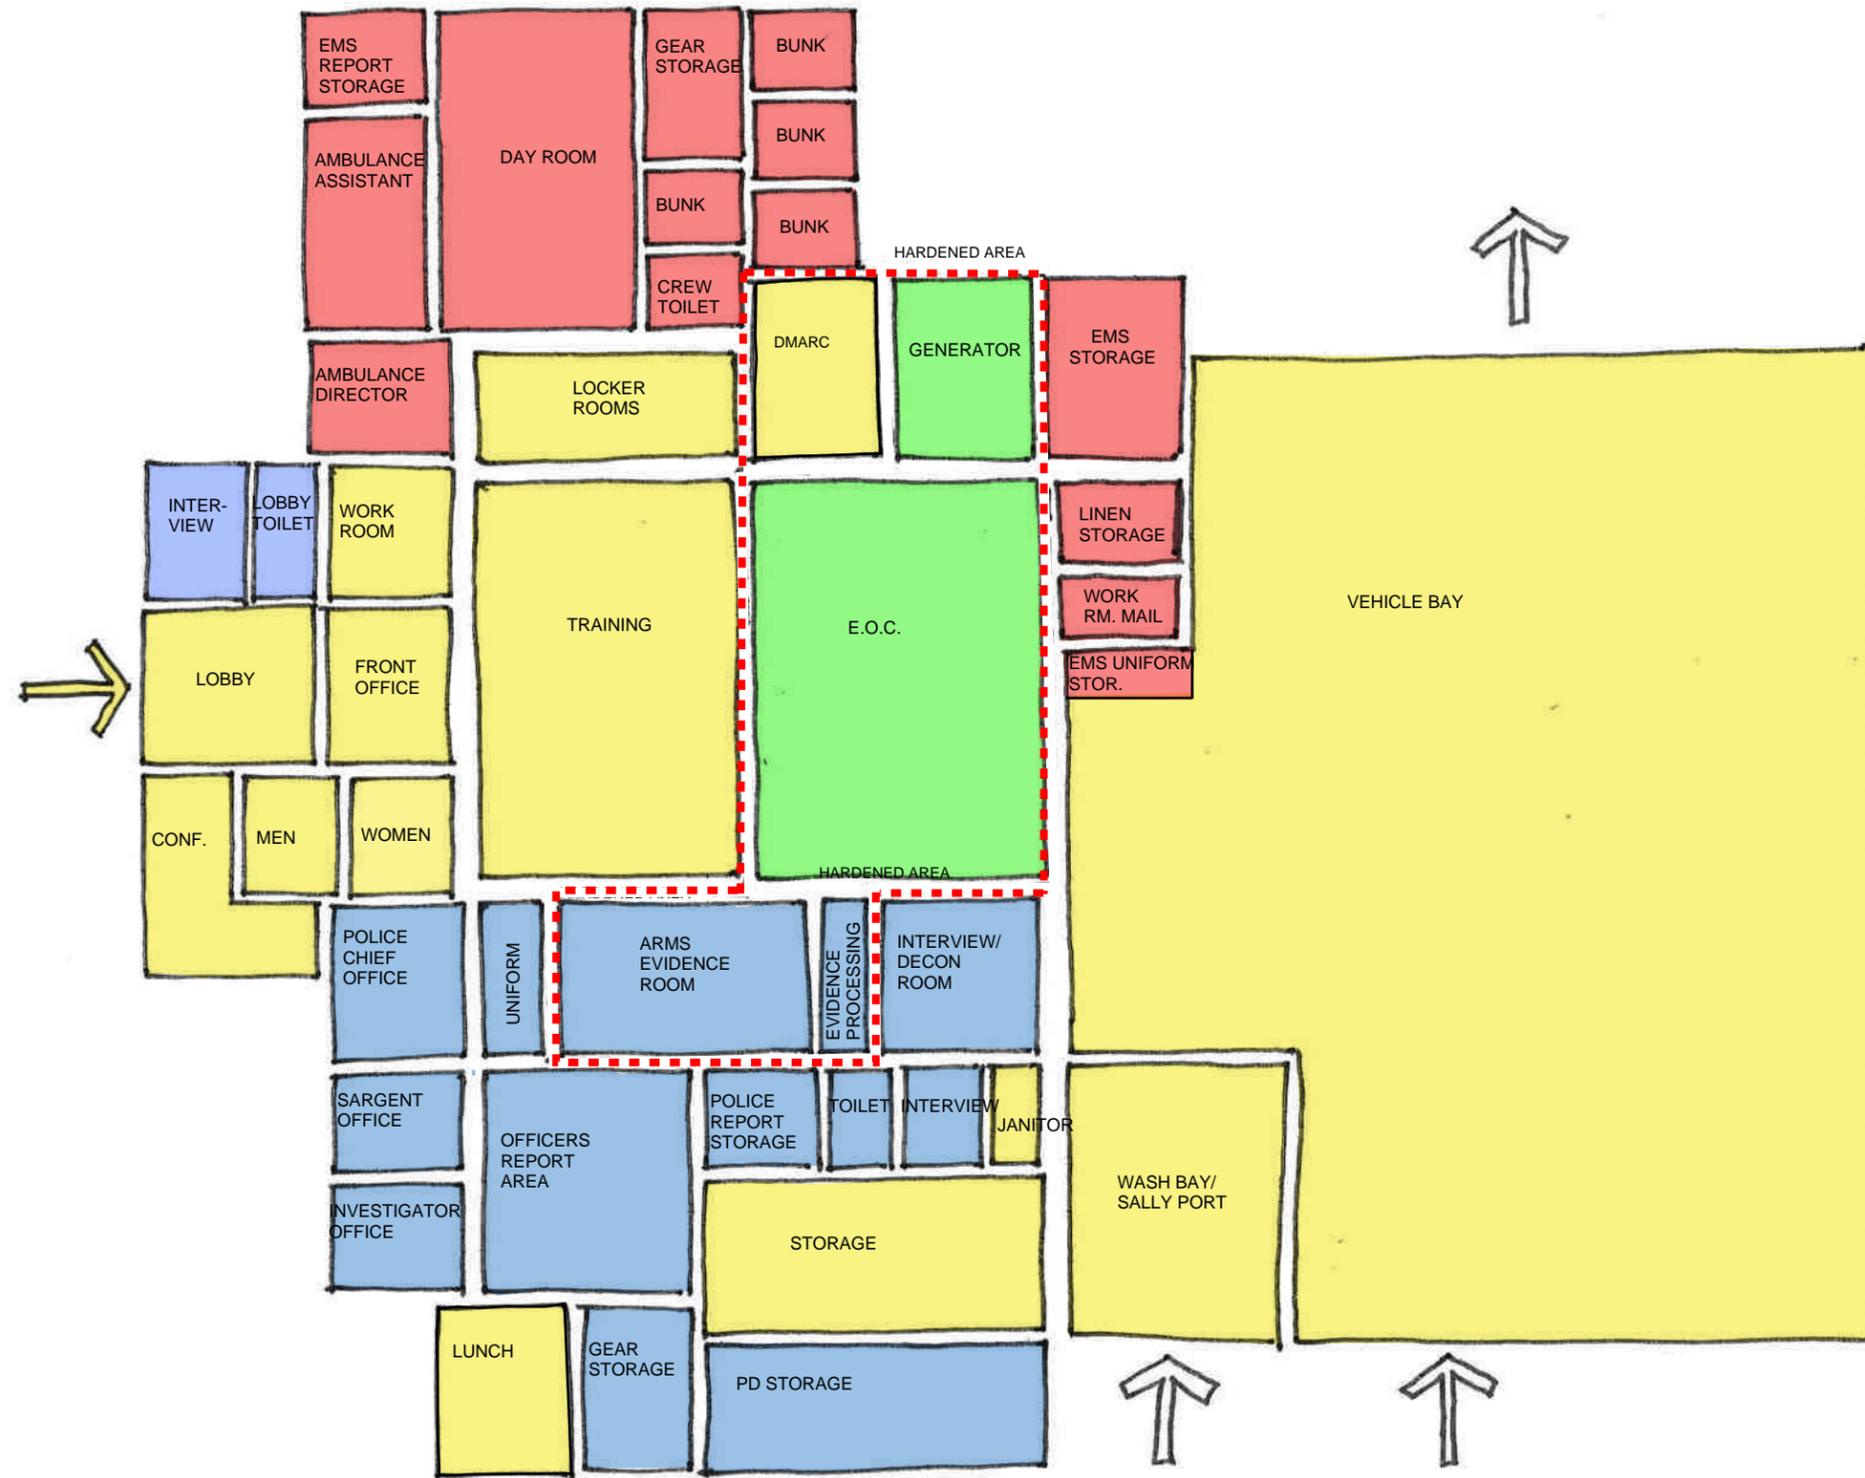
SF AREA
ARMS/EVIDENCE ROOM	284
PD OFFICES: CHIEF, INVESTIGATOR, SARGENT	341
PD GEAR STORAGE	126
INTERVIEW/DECON ROOM	182
EVIDENCE PROCESSING	52
INTERVIEW ROOM	64
TOILET ROOM	45
OFFICERS' REPORT AREA	342
STORAGE	330
PD UNIFORM STORAGE	65
PD REPORT STORAGE	90
LOBBY TOILET ROOM	60
LOBBY INTERVIEW ROOM	100
<b>TOTAL</b>	<b>2,081</b>
EOC/KITCHENETTE/TOILET ROOMS	910
GENERATOR ROOM	180
<b>TOTAL</b>	<b>1090</b>
LOBBY	195
FRONT OFFICE AND WORKROOM	231
TRAINING ROOM	782
TOILET ROOMS	160
STORAGE	390
JANITOR ROOM	32
VEHICLE STORAGE BAY	5,857
CONFERENCE ROOM	184
LOCKER ROOMS	190
LUNCH ROOM	180
DMARC ROOM	165
<b>TOTAL</b>	<b>8,366</b>
EMS OFFICES: DIRECTOR, ASSISTANT	318
EMS GEAR STORAGE	104
BUNK ROOMS	216
EMS CREW TOILET ROOMS	60
DAY ROOM/KITCHENETTE	476
LINEN STORAGE/MEDICAL SUPPLIES	70
EMS WORKROOM/MAIL	60
EMS STORAGE	180
EMS UNIFORM STORAGE	36
EMS REPORT STORAGE	80
<b>TOTAL</b>	<b>1,600</b>
<b>TOTAL BUILDING AREA</b>	<b>13,137</b>
BUILDING CIRCULATION	1,971

<b>TOTAL BUILDING AREA</b>	<b>15,108</b>
